KENNEBECASIS WATERSHED RESTORATION COMMITTEE

Restoration Site Portfolio

1995-2022

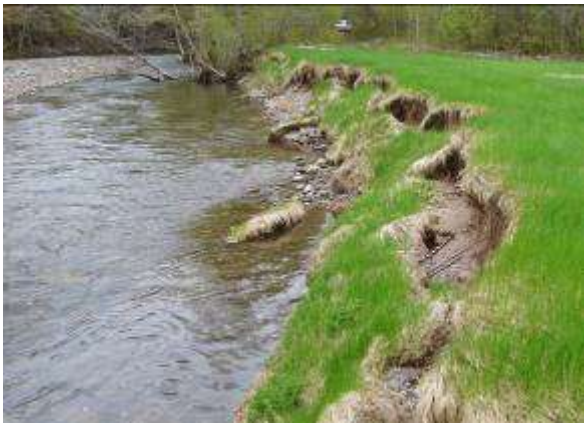
The Lanigan site as it looked in the spring of 2015.

In 2013, Chris Lanigan approached the KWRC after purchasing property along Trout Creek with concerns about his access point to the property. In 2014, landowners from DeForest Road had similar concerns and the KWRC hosted a meeting of landowners along the reach, and 3 sites were identified as concerns for aquatic habitat and sustainable land use. The Lanigan site possessed a 45-metre long bank ranging from 1.5-2 metres high that was severely eroding and introducing sediments into the river. The KWRC proposed a rip rap approach due to limited available space; this approach was completed in conjunction with rock kickers to maintain habitat function and protect a deep pool at the site.

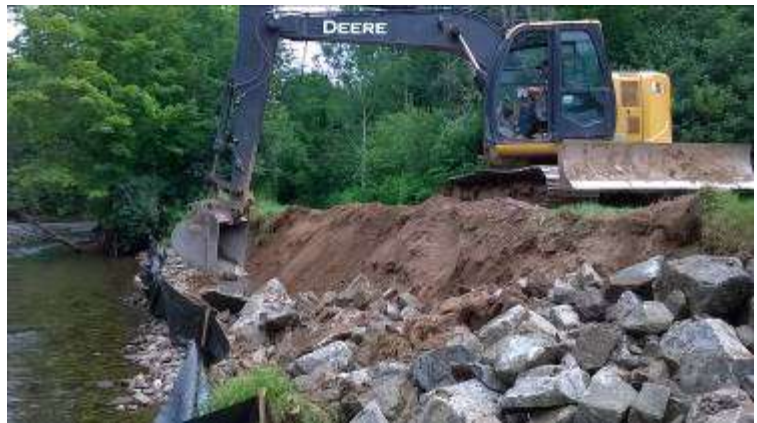
During the summer of 2015, rock was placed by an excavator.

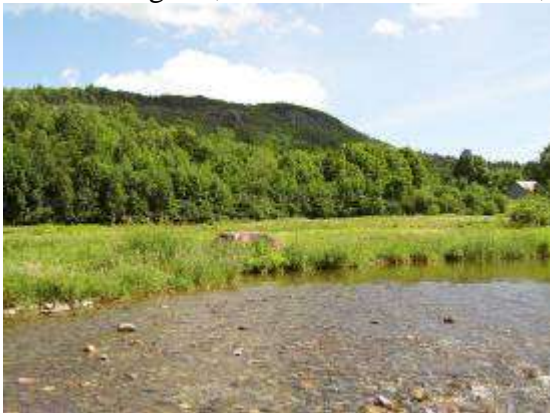
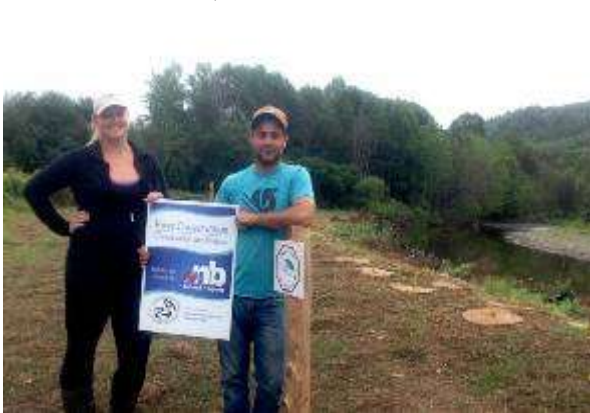
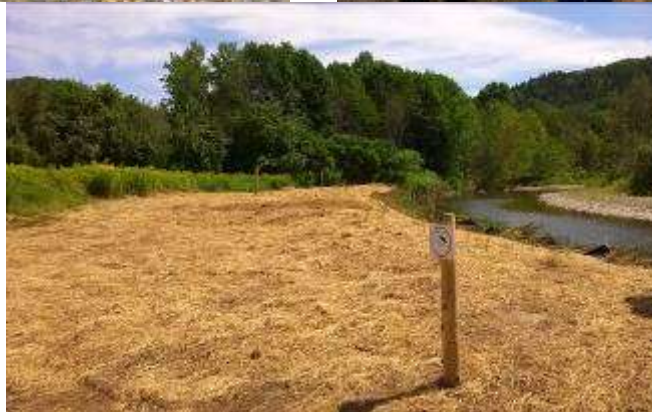
Rock toe armoring, fascine bundles, and geo-roll installation were utilized to stabilize the degrading stream bank while also protecting the integrity of the wetland. This effort will reduce the chance that the river will flow onto the road creating land-use conflicts. KWRC staff also performed some willow staking along the gravel bar below the main site to further separate the creek channel from the roadway. Funding for the project came from the Atlantic Salmon Conservation Foundation, Recreational Fisheries Conservation Program, NB Wildlife Trust Fund, CN EcoConnexions, and Tree Canada.

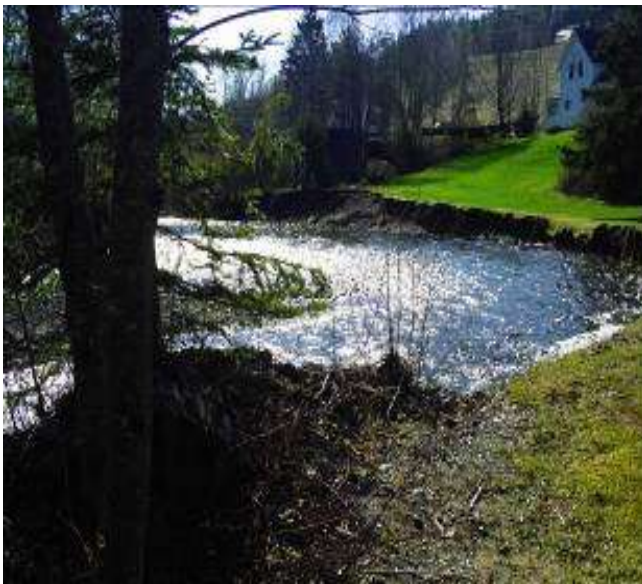
Before

This site possessed a long and extremely high bank. The Trout Creek was threatening two septic systems and thus the bank had to be stabilized. By using rock armoring the slope could be adjusted to 2:1 and thus provide enough room for the septic systems in question. The armoring will also result in a reduction of sediment transfer into the water and this will serve to enhance breeding habitat for salmonids in the system. The eroding bank was over 3m high in some spots which meant large rock material was needed. The work took approximately 3 days from the first rock delivery to when grass seed was spread. Tree planting took place in the fall of 2015 when caliper trees were planted.

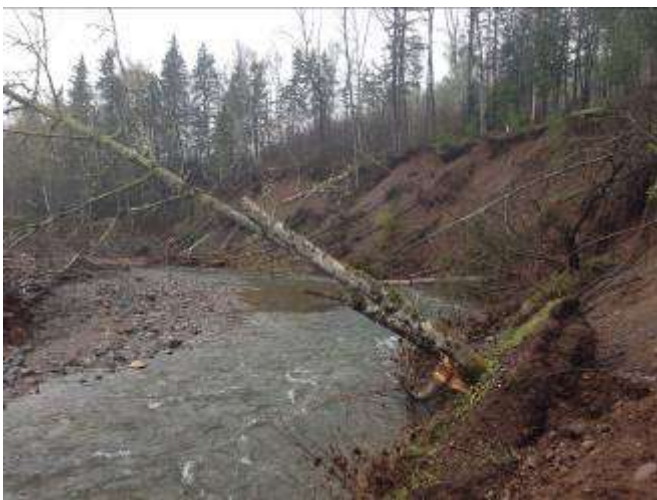
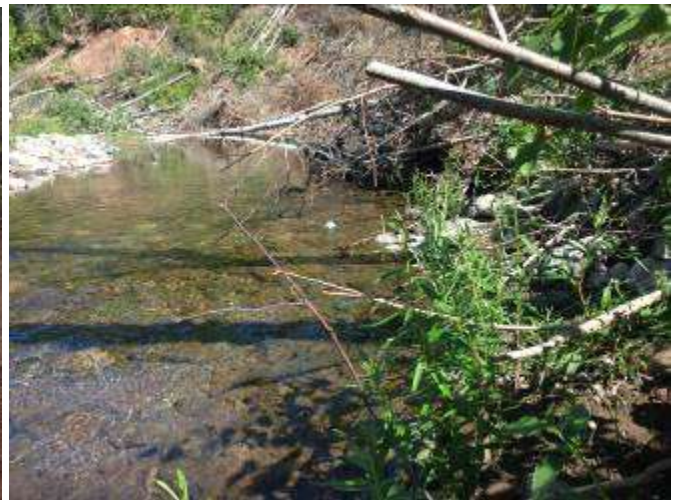
The landowner at this property reached out to the KWRC in 2017, concerned about the severe bank erosion they were encountering on their property. The bank is extremely high and steep along their stretch of Trout Creek. We completed a site assessment and determined that planting willow would be our best option. Our field crew staked a total of 537 willow stakes along the toe of the 80m length of bank. We plan to revisit the site in the years to come to spot plant as needed until the vegetation takes.

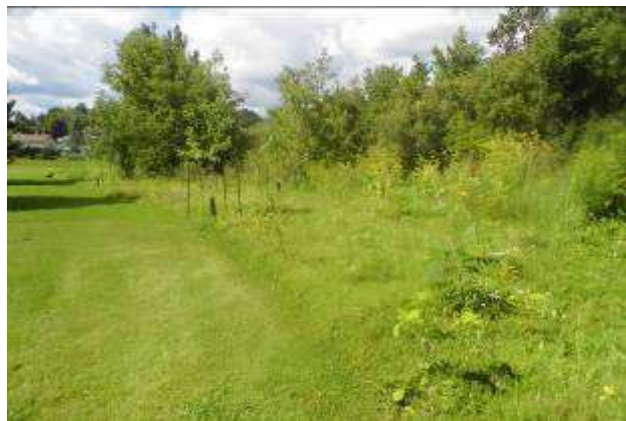
By August of 2015, the riparian setback had improved and most of the trees were growing successfully.

Students from Sussex Middle School assisted in the planting effort and we hosted an education event at the site to kick off our 2015 restoration season. In total, there were 84 trees planted at the site which is approximately 145 metres long. A setback of 8 metres was established and this should serve to establish the needed vegetated riparian area and protect homes from future flooding impacts.

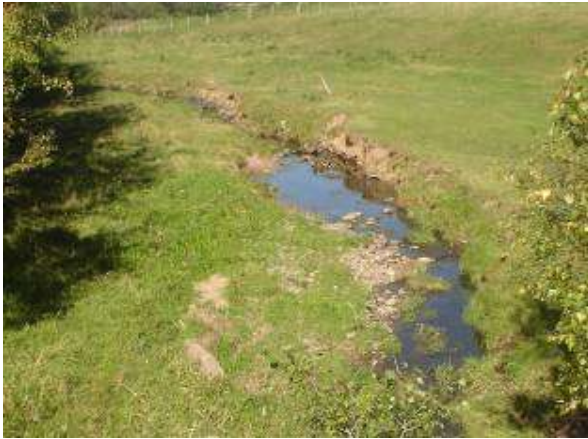
Before

The Kennebecasis Watershed Restoration Committee commenced this project in 2009 intending to restore the aquatic and riparian habitat for 1.4 kilometres of stream on a farm operated by Jim and Paul Walker. With funding from Potash Corp, we were able to plant over 8500 trees along the degraded riparian area, stabilize more than 200 metres of eroding stream bank, install more than 12 rock groynes to improve fish habitat, install 5 stabilized fording sites, and erect more than 2 kilometres of 3-strand barbed wire fencing.

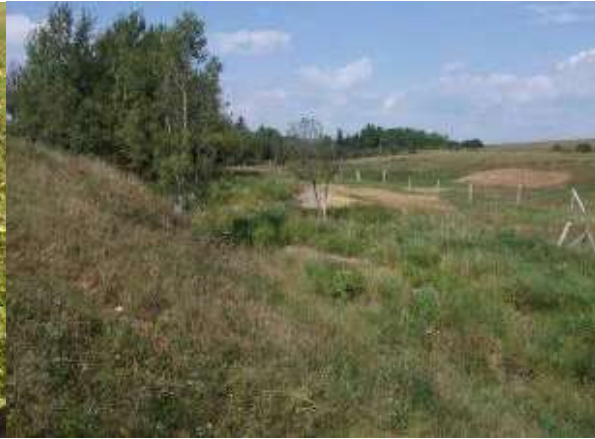
After

The final tree for this site was planted on October 5, 2011, during an open house event that acknowledged the partners involved in this large undertaking. Ongoing stream temperature monitoring is taking place to evaluate the success of the site.

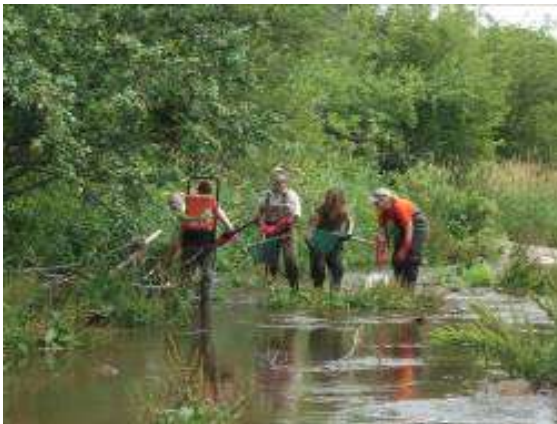
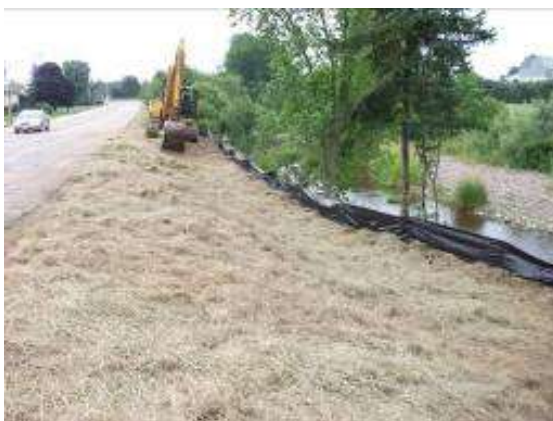
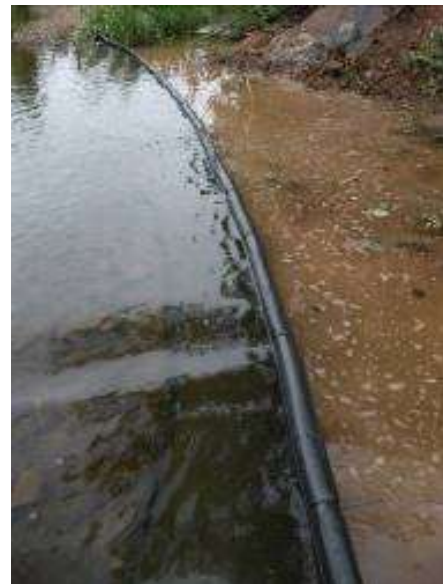
This project was carried out through the summer of 2011 with the final touches being done that same fall. The objective of this project was to stabilize a severely eroding bank in order to protect the infrastructure within the Town of Sussex, including Magnolia Avenue. Approximately 80 metres of stream bank was stabilized which will reduce sediment input from erosion, as well as chemical input from the roadway. Six rock groynes were installed to improve fish habitat and slow the stream flow during high water events. To further enhance the site, a number of willows, oak, cherry, maple, and pine trees were planted. To prevent negative impacts to the stream during the project, our team used a handmade floating silt curtain, which was both cost-effective and effective at containing the sediment.

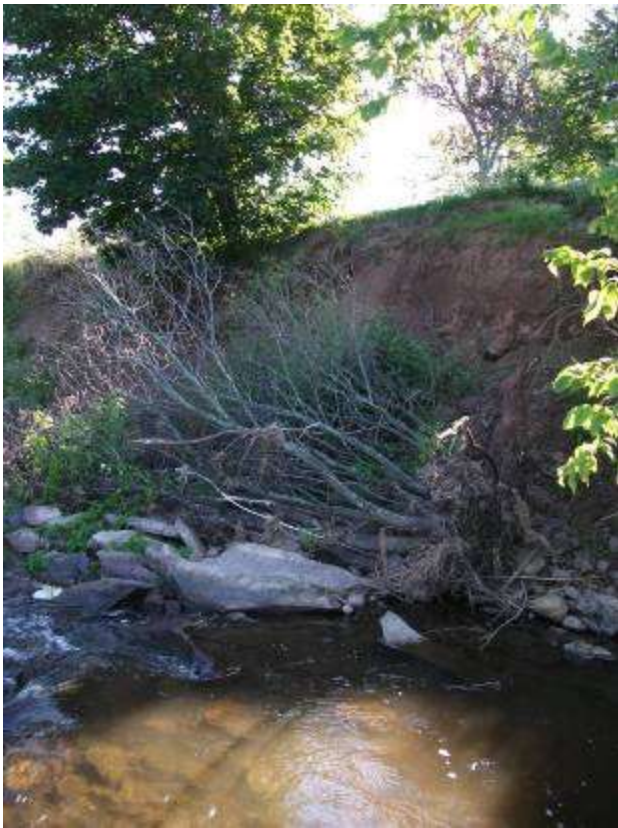
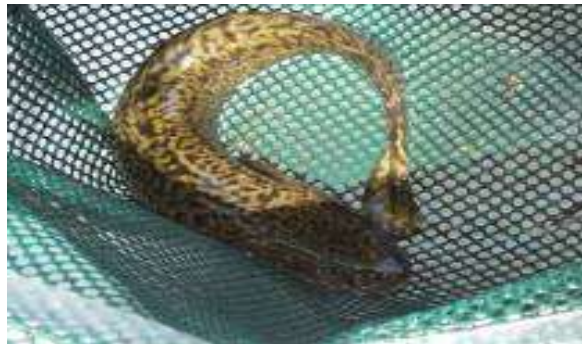
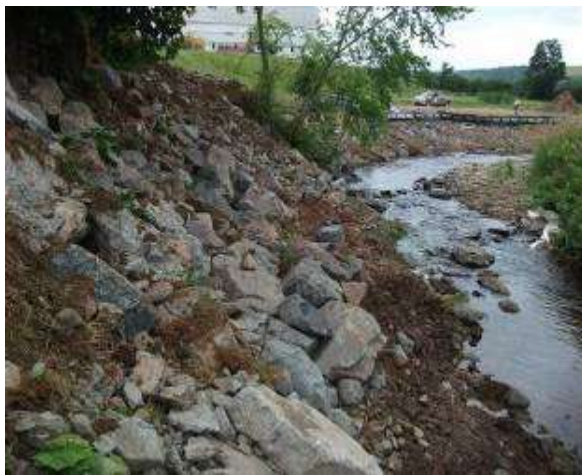
With work previously being completed upstream of this farm site, it was important that the KWRC also work to protect and enhance this farm site. With a long and severely eroding stream bank that has been on our priority list for some time, it was rewarding to complete this site in 2011. The farmer had already been fencing his cattle away from this stream bank but with available resources, the KWRC stabilized a 95m section of stream bank, installed 5 rock groynes to improve fish habitat, and planted several trees to improve site biodiversity and improve riparian zone health. During our fish rescue efforts, before construction, staff discovered a burbot. This was the first time it had been seen in Ward's Creek.

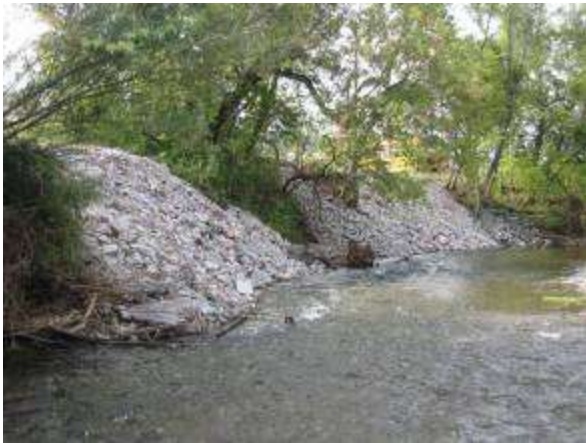
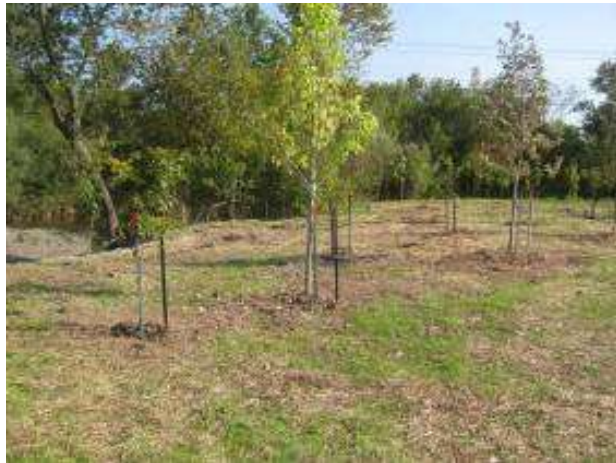
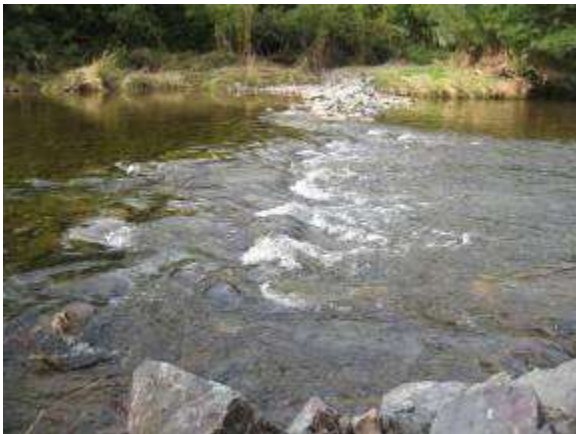
In 2008, the KWRC partnered with the NB Department of Transportation stabilized the stream bank and installed a rock sill. It was also decided that caliper trees would be planted along with some one-gallon potted stock, due to the high visibility of the site and the adjacent land-use. Maple, ash, and pine have been planted here. One year after the work was completed, the very mobile Trout Creek shifted an entire gravel bar, so future projects may be planned for this site.

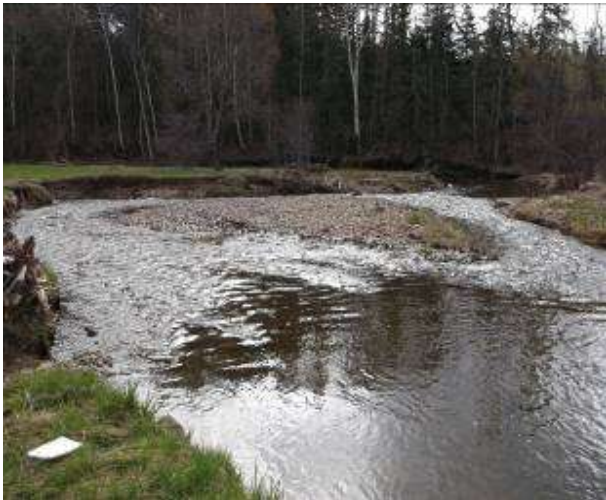
Before

This site was facing erosion issues and the landowner was concerned with loss of topsoil into Wards Creek. The bank was planted with willow seedlings and stakes in the summer of 2013 to decrease erosion. Beginning on September 16th 2013 the KWRC excavated the bank back to add rock armouring and willow stakes to the bank. A trench was dug in order to bury 8ft lengths of willow stakes within placed rock and soil. The riparian area was then planted with a variety of tree species in order to establish some shade cover over the stream.

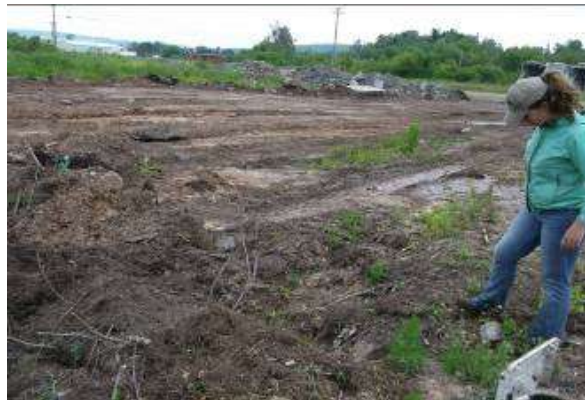
Before

Originally a sewage treatment facility and aeration pond, this site was later then filled with scrap rock, asphalt, and concrete. To restore the site, the area had to be leveled and sloped to allow rainwater to run off smoothly into Trout Creek. Large rocks were placed at the toe of the slope in hope that this would create a drainage channel into Trout Creek. A variety of tree species were planted and a mulch trail and raised flower bed were added to the site to create a recreational area for residents. Many groups have volunteered their time to improve the quality of this site including Sussex Middle School, the University of New Brunswick's Environment and Natural Resources graduating class, and local Scouts groups.

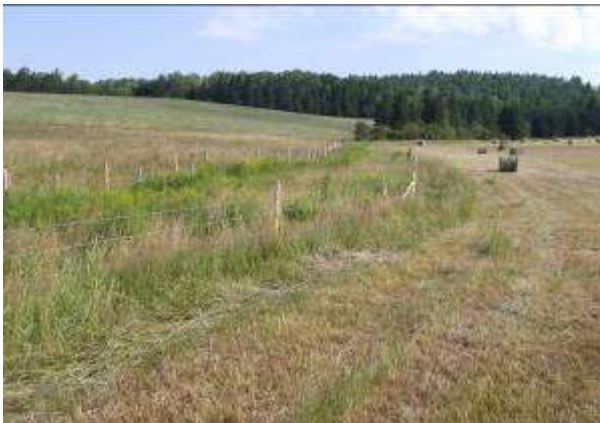
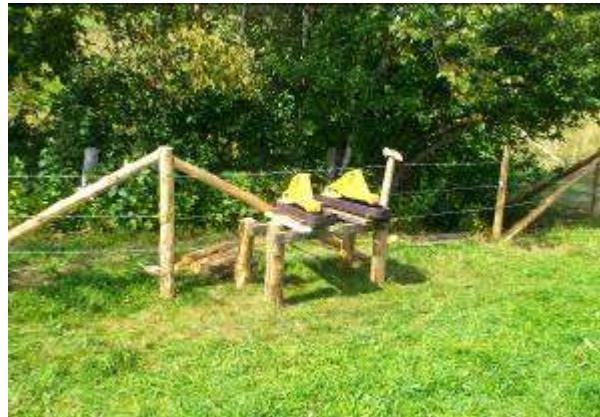
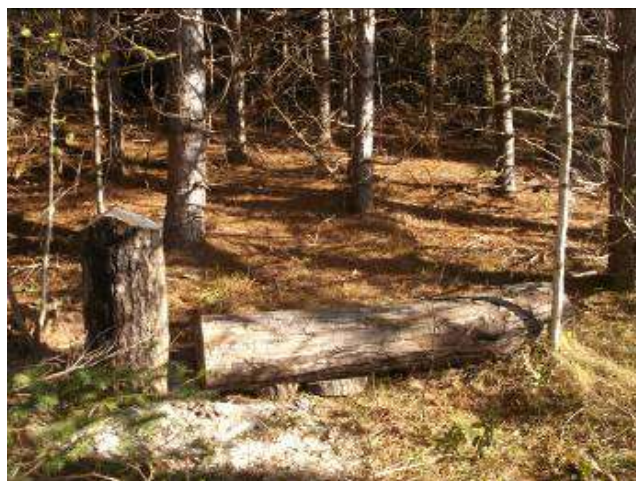
12. Shannon Farm Riparian Restoration & Ruffed Grouse Habitat Project (45.70688, -65.37868)

In 2013, a section of riparian zone along Shannon Brook was restored on Sam Shannon's farm in Waterford. Two kilometres of livestock fencing was installed and a variety of tree species were planted in the riparian area. Nose pumps were installed to give cattle access to drinking water from the stream. As part of our *Ruffed Grouse Habitat Project*, trembling aspen (*Populus tremuloides*) were planted and drumming logs were installed. Trembling aspen provide habitat and food for ruffed grouse. Drumming logs give ruffed grouse an area to attract a mate and mark their territory by drumming their wings on their breast.

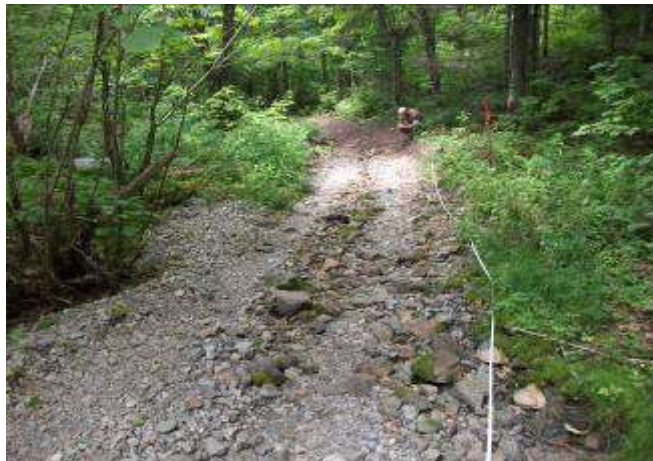
Before

In 2013, an ATV trail in Turkey Hollow was having flooding issues due to an ephemeral stream crossing the trail. Instead of the stream remaining in its channel, the water flowed down the trail. The stream was channelized and logs were placed to provide a barrier between the two. Bridges were built in three areas where the stream crosses the trail so that the channel can be re-established.

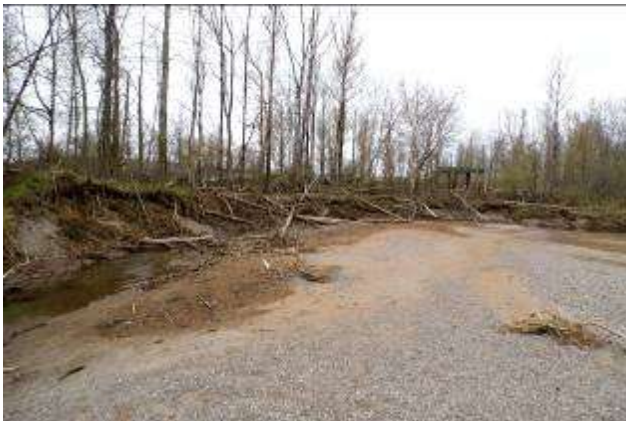
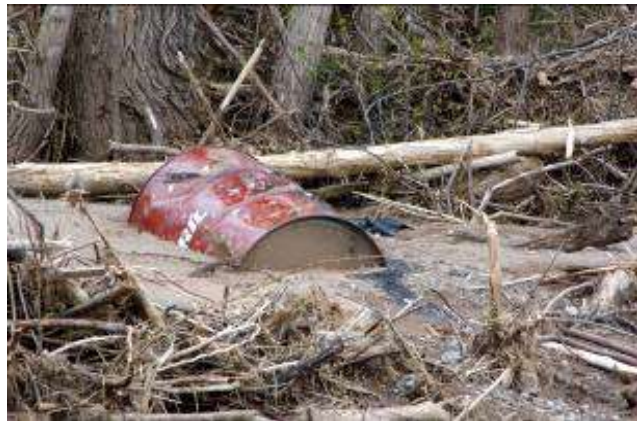
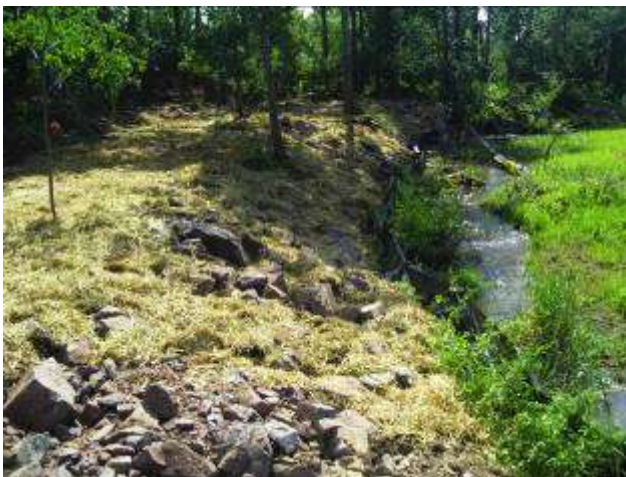
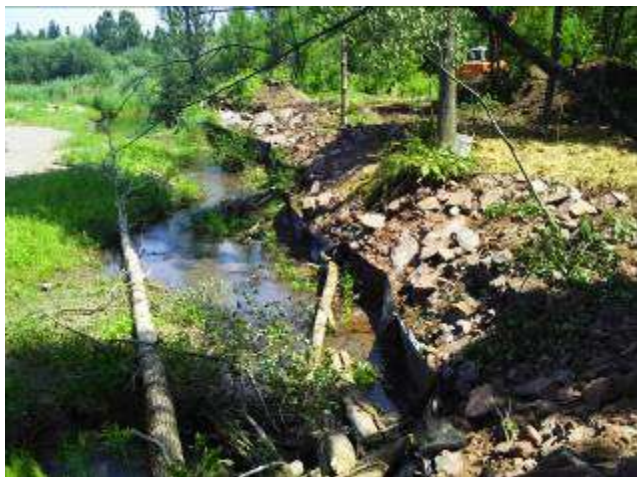
14. Improving Industrial Riparian Areas: Brown's Paving (45.71653, -65.47936)

In 2014, the KWRC undertook this project in partnership with Brown's Paving to improve industrial riparian areas along the Trout Creek. The KWRC also hosted a workshop for the Brown's Paving employees about working responsibly near watercourses. Rock armouring was installed, and trees were re-planted to help stabilize the bank on their property which was being heavily eroded.

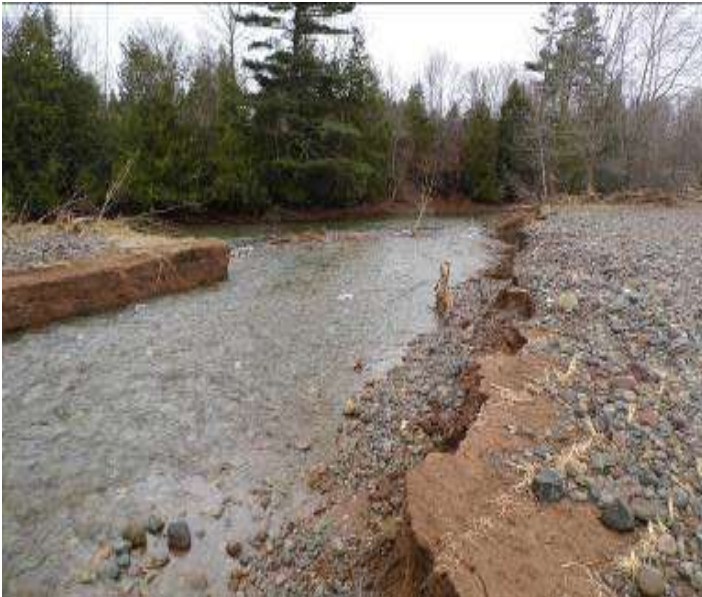
Before

The KWRC began consultation with the landowner in 2013 regarding the restoration of an eroded bank. After the spring of 2014, the landowner lost a considerable amount of land when the stream broke its right bank and formed a new channel into an adjacent field. The KWRC decided to use rock armour to stabilize the 70-metre long bank and, instead of fixing the channel, let the stream run its new course, restoring the surrounding land. Staff planted 570 trees, 6 of which were caliper trees, as well as willow stakes. The design of the site has been created so that if there are any major floods, the water will come up and be negated by the slope of the bank.

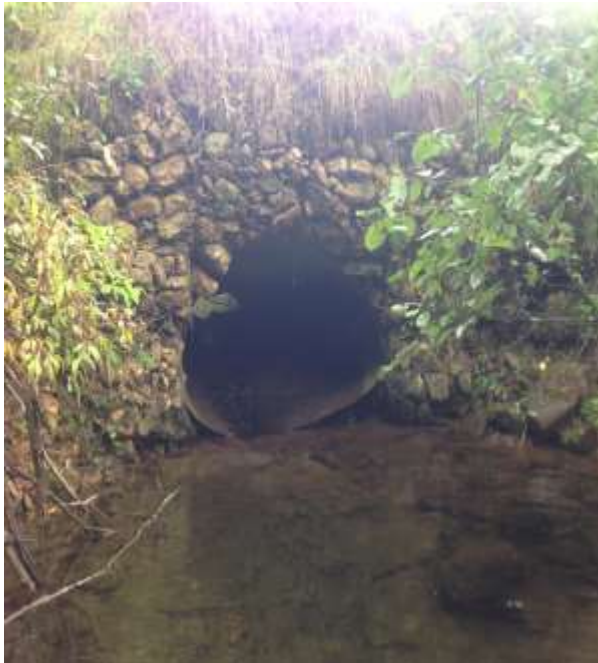
This rock weir is located on a tributary to Trout Creek and was installed as part of our *Fish Passage Barrier Removal Project* in 2016. Before installation, the culvert had a perch of 22 centimetres which was restricting fish passage to viable habitat upstream of the culvert. After the rock weir was installed the perch was less than 8 centimetres. Fish passage was successfully improved through this effort and now an additional 950 metres of viable fish habitat is accessible to fish species.

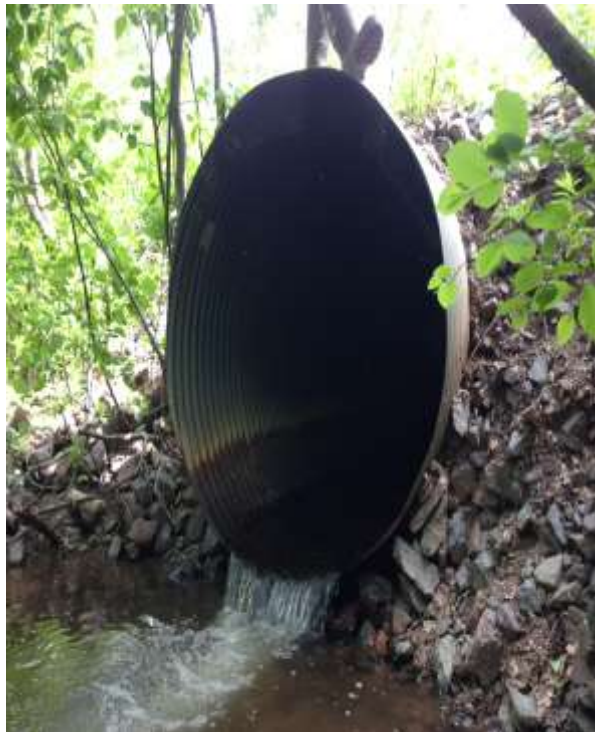
Before

This rock weir is located on an un-named tributary to Cedar Camp Brook, which flows into Trout Creek in Waterford. This culvert was re-assessed on June 14th, 2017 and the perch on that day was 15 centimetres; although this is less than what was originally recorded in 2010, it still exceeds the recommended maximum perch of 10 centimetres. The rock weir was installed on August 11th, 2017; on that day the perch was at 18 centimetres. KWRC staff were able to decrease that perch to 6.5 centimetres and fish species will now be able to access an additional 2.7 kilometres of stream habitat year-round.

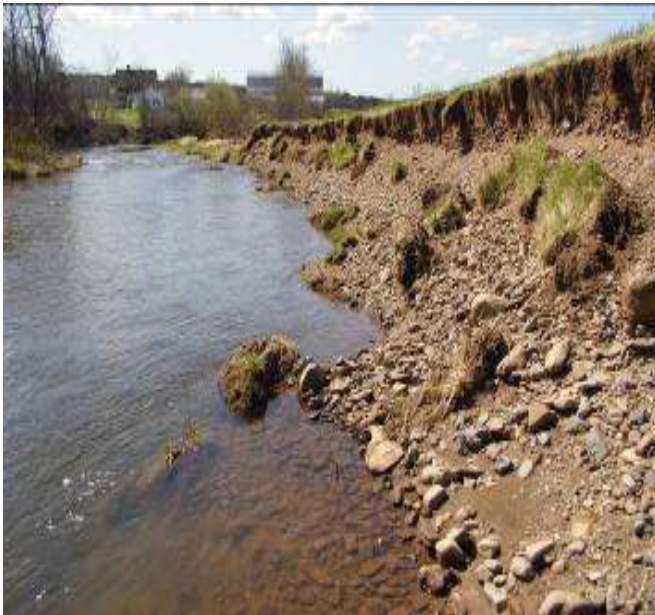
Before

In 2014, this site served as one of the locations of a pilot project using biodegradable geotextile products in our bank stabilization efforts. The streambank and farmland were eroding prior to restoration efforts. The geo-textile products allowed us to stabilize the stream bank while establishing a setback of just 7 – 8 metres; this was beneficial as the farmer wanted to maintain as much of his use as possible. Trees and shrubs were planted following the stabilization work. The total length of the restored streambank was 54 metres.

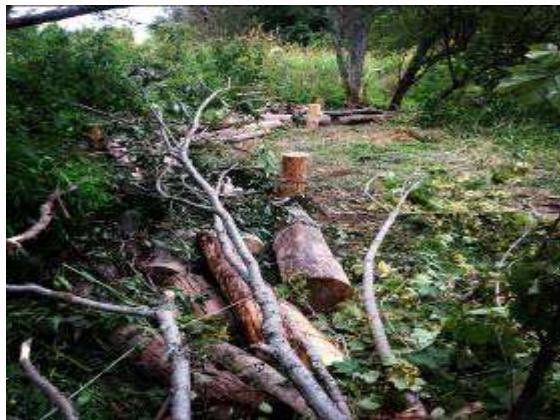
Tree Revetment

Below the newly stabilized bank, we created a 20-metre-long tree revetment, using wood from the site. Some of the wood was lying horizontal to the flow of the creek, impeding flow and/or directing flow towards an already eroding stream bank; others had to be removed to install the rock and bioengineering. The tree revetments will help protect and build-up the bank by catching sediments and other debris during high water events. This effort was done to protect the properties behind the revetment.

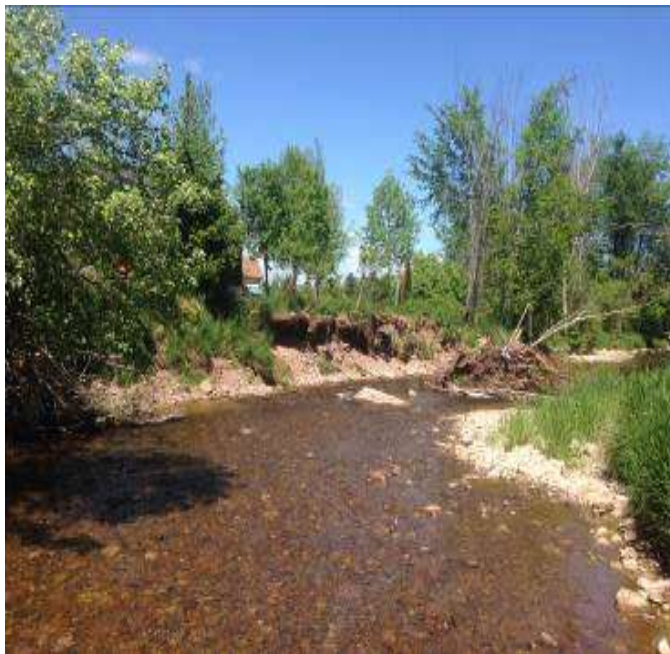
Before

The landowner at this location was continuously losing parts of his property to erosion each year during the spring freshet. This 22-metre-long bank was back-sloped to improve floodplain connectivity and rock armoured to prevent further erosion. Rock kickers were installed on the upper and lower end of the bank to mitigate possible changes in hydraulic flow. Trees and shrubs were planted within a 5 metre buffer zone along the bank; this included 6 serviceberry shrubs and 4 caliper stock red oak. 34 willow stakes were also planted along the toe of the bank.

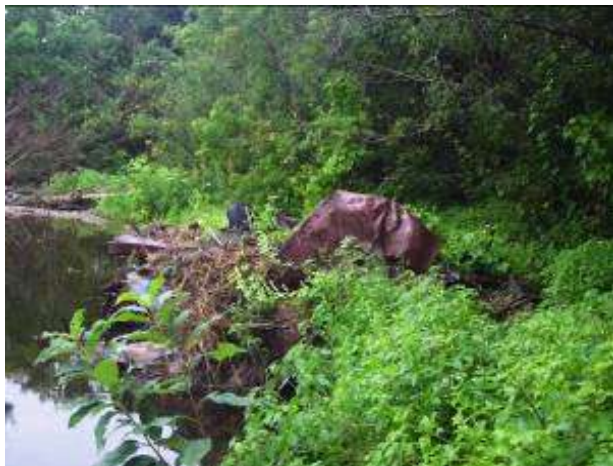
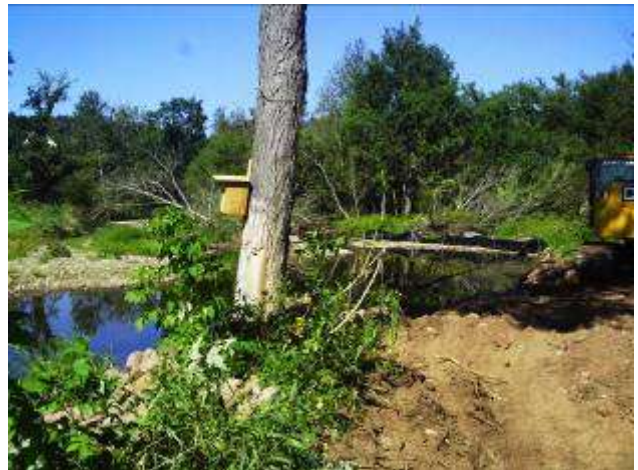
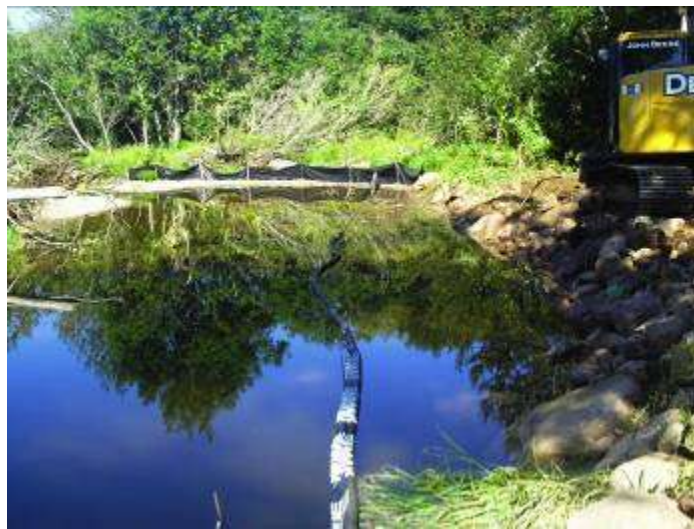
22. Lower Ward's Creek Fowler Avenue Restoration Site (45.71591, -65.50135)

This project was part of our 2014 *Habitat Connectivity Project* and the *Industrial Riparian Zone project*. The KWRC removed 3 dump truck loads of junk cars, scrap metal, etc. from the site, stabilized a degraded stream bank, installed bird boxes, and planted native trees and shrubs along the disturbed area.

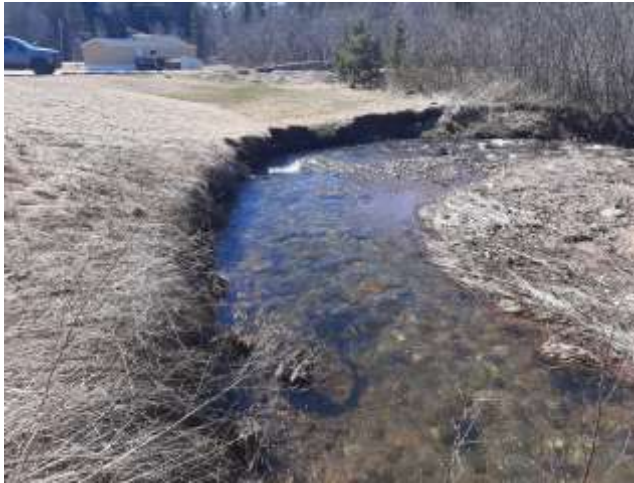
Before

The *Riparian Enhancement at McFarlane Road* project was completed in 2020 and was focused on stabilizing a stream bank along Shannon Brook, a tributary within the Trout Creek sub-watershed. The KWRC installed a rock toe and back-sloped the bank using an excavator, then used willow brush layers and erosion control blankets to prevent future erosion. Finally, our team planted approximately 50 willow stakes and four caliper stock trees at the site, to provide shade to the stream once the vegetation matures. This project stabilized 30 metres of previously eroding stream bank and enhanced an estimated 300 square metres of riparian zone.

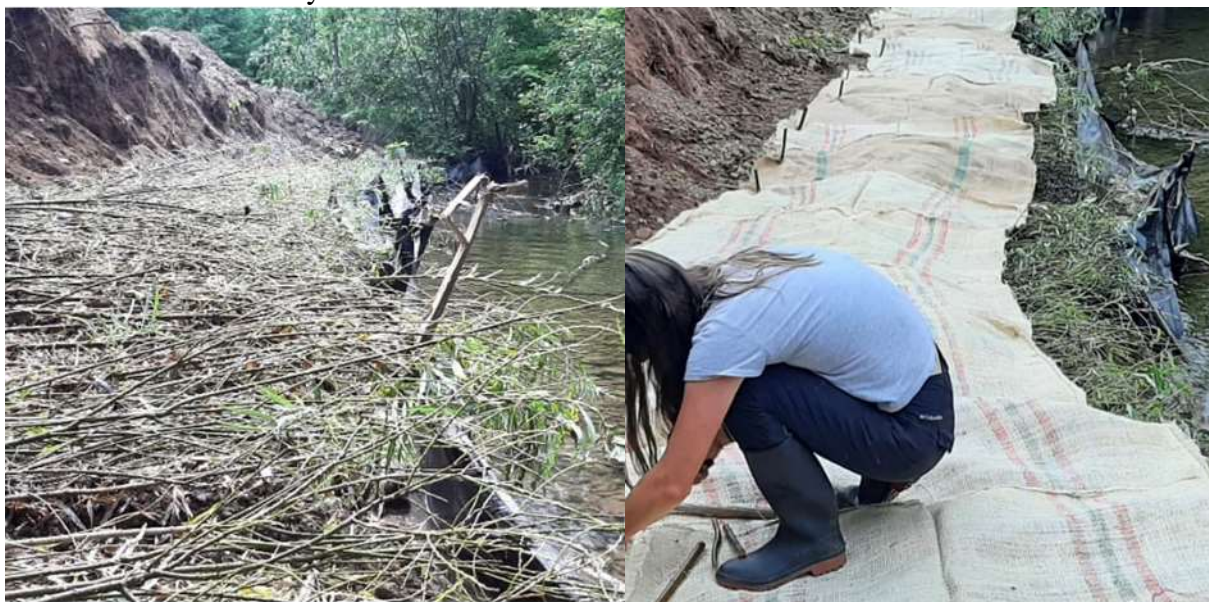
The goal at this restoration site was to remove a 30m section of eroding riparian zone and replace it with a stable bank that can withstand flood level waters without allowing further collapsing of the bank. To begin, a silt fence was installed to prevent sediment from getting into the water during removal of the bank. Vegetation and loose eroding soil was excavated from below the water line to the top of the bank and a rock toe was installed. A layer of soil was then placed on the rock toe so that the brush mat of willow whips could be placed along the length of the bank. Around 500 willow whips were placed then covered with another layer of soil.

Instead of erosion control blankets coffee bags were laid out along the length of the bank slightly overlapping each other, then half covered in soil and folded back on themselves then staked into the ground with willow stakes to hold back soil and keep it from collapsing. We repeated this process two more times in rows above the original to make three levels of soil filled coffee bags. The soil above the coffee bags was then back sloped to meet the field above. Topsoil was spread over the top of the bank which we spread grass seed over. We also planted nursery trees along the riparian zone and in the field across the brook.

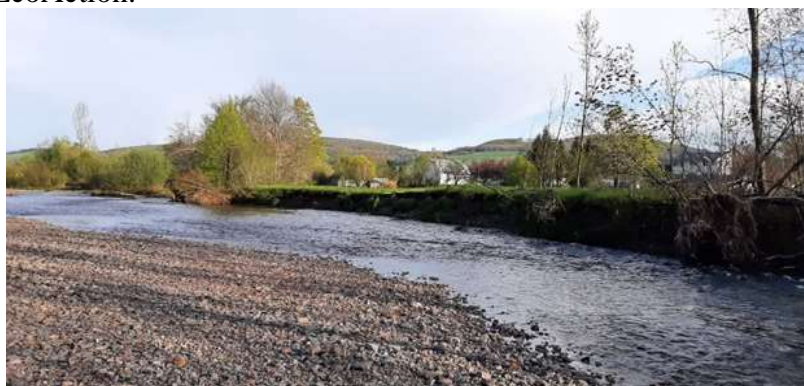
BEFORE

In 2021, the KWRC began working at Buchanan’s site to stabilize the bank to prevent further erosion. The site is an agricultural field located along Trout Creek. Our team back-sloped the bank and rock armoured 45m of eroded streambank and created a 15m riparian setback. Over two years (2021-2022) the KWRC staked 350 willows to aid the stabilization of the bank and planted 136 trees within the riparian setback. There were 4 bird boxes and 1 duck box installed. This project was supported by ETF, WWF, ASCF, and EcoAction.

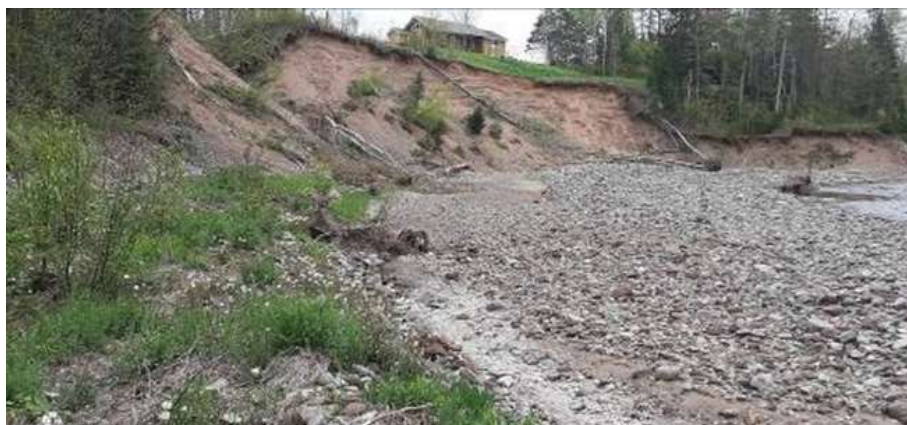
Large Eroding Bank

In 2022, the KWRC returned to Lisa McLean's property. Since 2017 there has been a large change in stream location. This change has allowed the KWRC to focus on establishing the bank toe to reduce bank erosion. There were multiple debris jams on Trout Creek and along a small ephemeral stream. Our team staked 723 willows and planted 15 trees along 130m of streambank. The KWRC team and Bad Axe removed a total of 3 debris sites along this stretch of the creek.

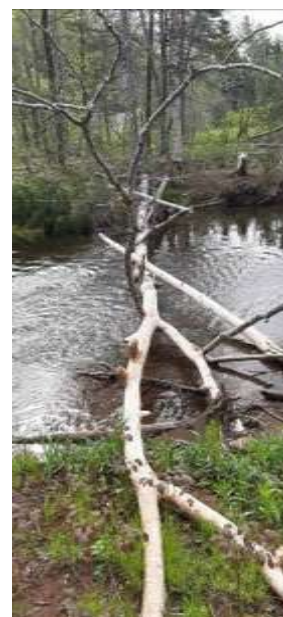
Debris Over Trout Creek

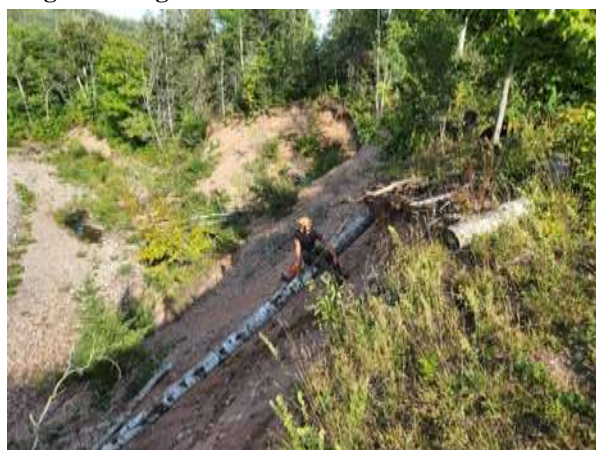
Figure 1 Debris Removal by Bad Axe

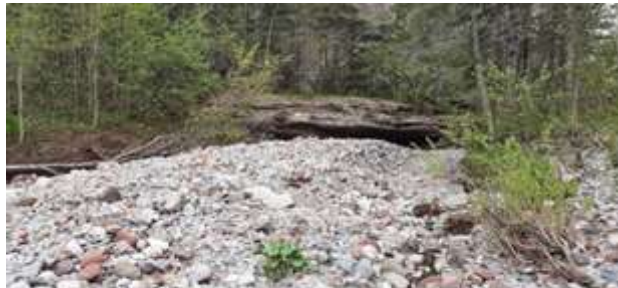
Large Gravel Bar

The headwaters of Trout Creek are just as susceptible to flood and large erosion events as the lower Trout Creek. In 2022, the team assessed the river along his property noting that there were large bedrock formations that would make restoration difficult. The team implemented a plan that would help large quantities of water flow better through the channel rather than eroding the surrounding banks. This involved removing 4 debris jams with the help of Bad Axe, adjusting 2 gravel bars, staking 80 willows, and planting 95 trees/shrubs.

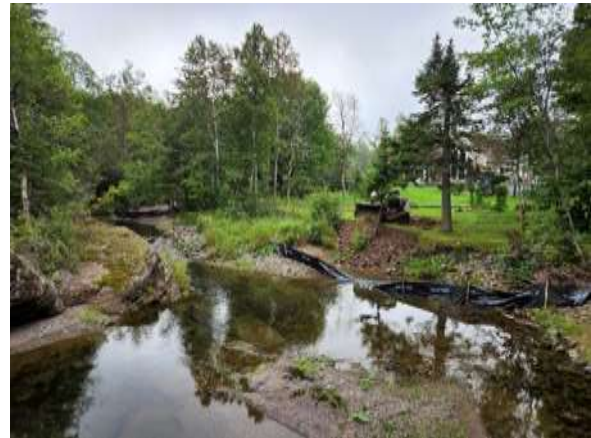
New Gravel Bar Location

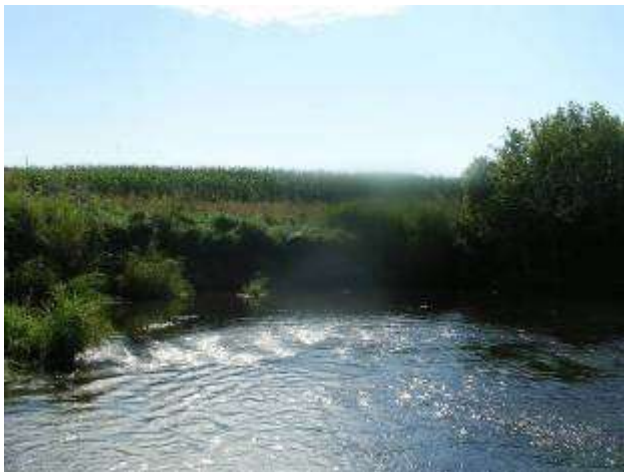
Before

This site was first established in 2011 with a great deal of work being completed in the summer of 2012. Following up on previous work completed in the area, which included riparian planting and a stabilized fording site, the KWRC wanted to utilize bioengineering techniques to stabilize an eroding bank. The prescription for this site was wattle fencing along with planting the upper banks with various tree species. The wattle fencing was built using willows harvested from near the site. The length of the bank stabilized was 90 metres with an average bank height of 1.25 metres. In 2013, trees were planted on the top bank to establish a riparian area around the stream.

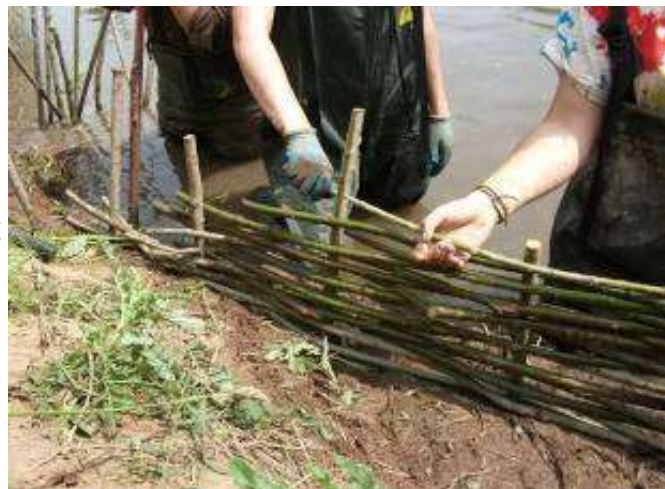
**Close-up of
Wattle Fencing**

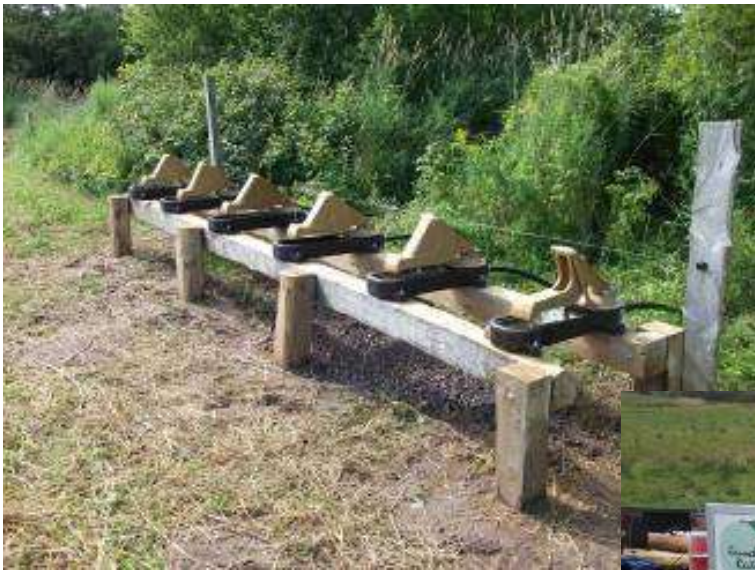
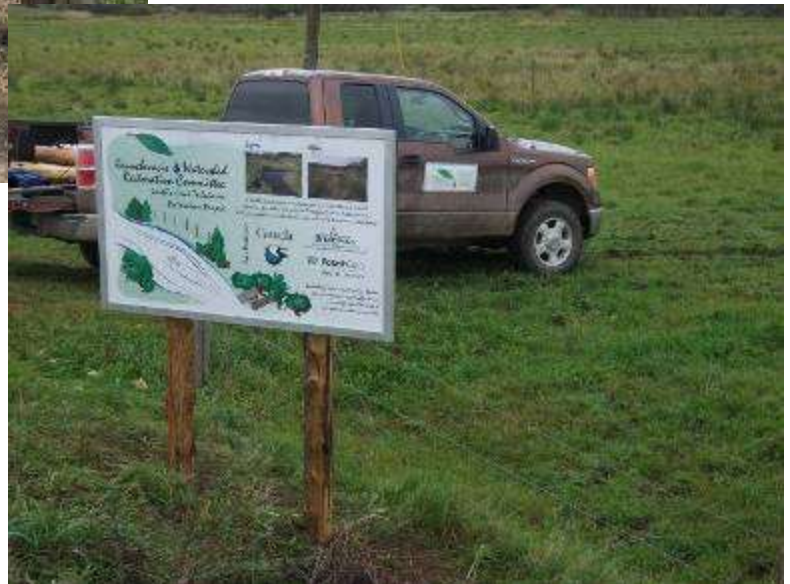
29. Culvert and Alternate Watering System Installation and Riparian Zone Enhancement: Keohanlane Farms (45.79774, -65.47376)

A small tributary to the Smith's Creek was experiencing high levels of sediment deposition and lacked the natural habitat functions of a healthy stream. To improve grazing and farming conditions on this property, and to enhance riparian and aquatic habitat, the KWRC suggested several tasks be undertaken. Cattle fencing was installed to protect the riparian zone along the entire field and six nose pumps were installed to provide water access to the cattle. A degraded culvert was replaced to improve stream hydraulics and various trees were planted along the stream to improve bank stability and add site biodiversity. Future work on this site may be needed to improve natural flow conditions which are being hampered by high sediment deposition along this low gradient stream section.

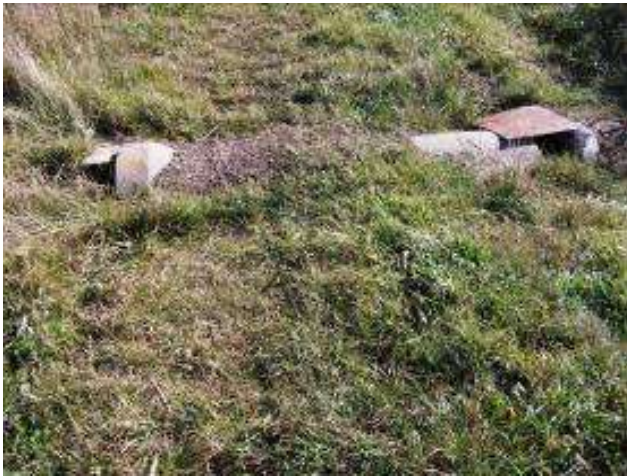
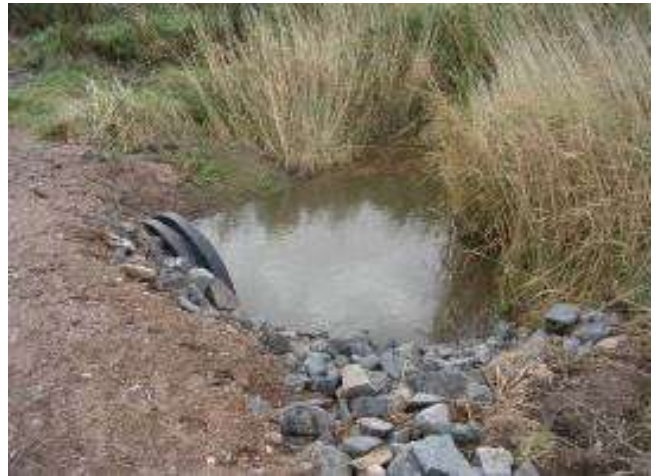
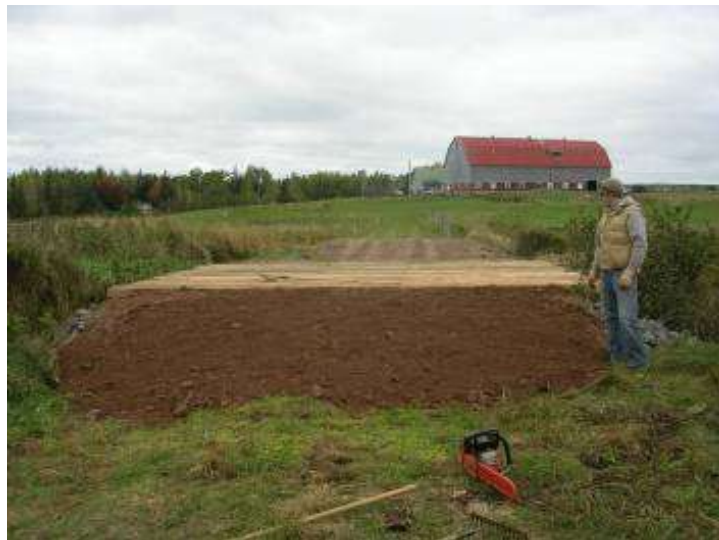
30. Kurihipi Station Crossing Enhancement Project (45.80088, -65.48108)

Poorly designed fording sites and crossings contribute greatly to habitat disruption across our watershed. When a landowner in the Upper Smith's Creek sub-watershed asked if the KWRC could aid in improving the conditions of his fording sites we agreed. A new culvert was installed on a first-order stream and a bridge was replaced on a second-order stream located on the farm. Partnering with Agriculture and Agri-Foods Canada allowed us to purchase the culvert and timber materials. The KWRC also worked with the Southern NB Wood Co-op allowing us to determine the requirements for the bridge.

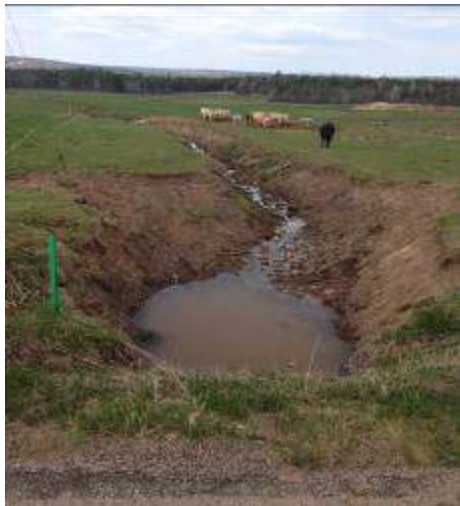
Before

A 1.8 kilometre stretch of eroding stream bank on two tributaries in the Smith's Creek Headwaters was identified on Justin Carll's property, during habitat assessment efforts in 2015. The stream flows from the road down through the cattle pasture and connects to the second tributary at the bottom of the pasture. The channel was deepening, causing the banks to steepen and prevent floodplain connectivity. There was a lack of vegetation and the lack of cattle restrictions to both tributaries, paired with high volumes of water during the spring runoff, was causing heavy erosion.

Fencing was erected along 1.1 kilometres of the tributaries, which established a 5-metre buffer on both banks of the tributaries through Carll's pasture. Rock armouring and rock toeing were installed throughout several locations along the stream through the pasture. Where rock toeing was installed, geo-rolls and fascine bundles were also used, and 5800 willow stakes were planted. In the future, we hope to see decreased stream temperatures as the shade cover increases with the growth of the newly planted vegetation. Vegetation planted along the 1.8 kilometre stretch included 894 willow seedlings, 827 tree seedlings, 175 potted stock trees, and 22 caliper stock trees. Four nose pumps were also installed to ensure cattle still had access to water.
