KENNEBECASIS WATERSHED RESTORATION COMMITTEE

Restoration Site Portfolio

1995-2022

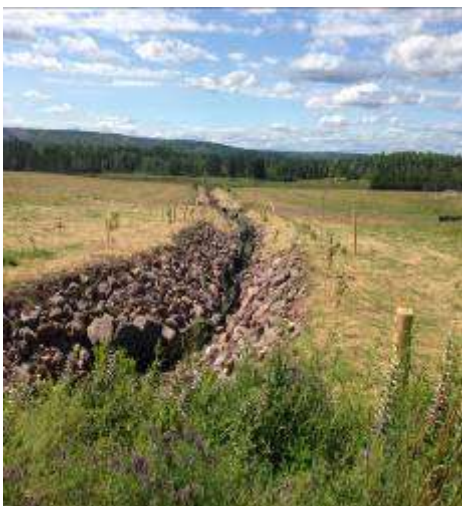
After

Fencing was erected along 1.1 kilometres of the tributaries, which established a 5-metre buffer on both banks of the tributaries through Carll's pasture. Rock armouring and rock toeing were installed throughout several locations along the stream through the pasture. Where rock toeing was installed, geo-rolls and fascine bundles were also used, and 5800 willow stakes were planted. In the future, we hope to see decreased stream temperatures as the shade cover increases with the growth of the newly planted vegetation. Vegetation planted along the 1.8 kilometre stretch included 894 willow seedlings, 827 tree seedlings, 175 potted stock trees, and 22 caliper stock trees. Four nose pumps were also installed to ensure cattle still had access to water.

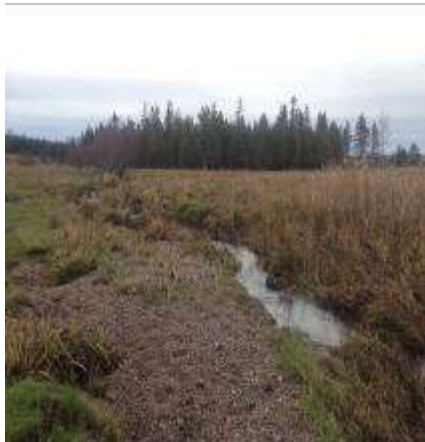
Before

The tributary running through Ken Carll's property is one of the main tributaries that flow into Smith's Creek from Knightville. Many tributaries flow into this one, including the tributaries we previously restored, on his son Justin Carll's property. The 257-metre stretch that flows through Ken's property was badly eroded. The substrate is composed of mostly fine sediments and sand, which can cause problems for aquatic species when disturbed by cattle and high water events. The banks are low and the floodplain connectivity was sufficient, but the lack of vegetation and lack of cattle restriction to the stream was negatively impacting water quality.

The KWRC erected 514 metres of fencing to create a 5 metre buffer around the tributary on the property. Four nose pumps were installed to allow cattle to access water. The area was also heavily planted, which will aid in decreasing stream temperatures and filtering out fine sediments during high water events in the future. 939 willow seedlings were planted along the tributary, as well as 69 potted stock and 6 caliper stock trees.

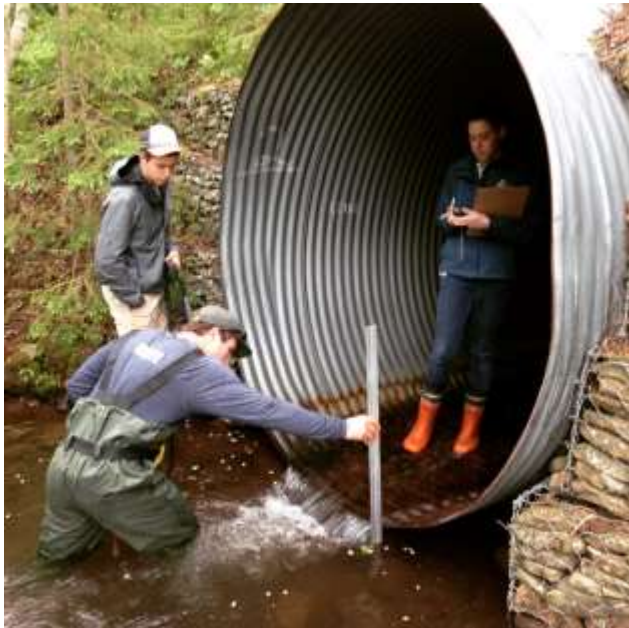
Before

This rock weir was installed as part of our *Fish Passage Barrier Removal Project* in 2017. It is located on the McGregor Brook, a main tributary to Smith's Creek. This perched culvert was identified in our 2010 culvert assessment effort and had a perch of 22 centimetres, restricting fish passage to viable habitat upstream of the culvert. After the rock weir was installed the perch was 3.5 centimetres. Fish passage was successfully improved through this effort and now an additional 1.7 kilometres of viable fish habitat is accessible to fish species.

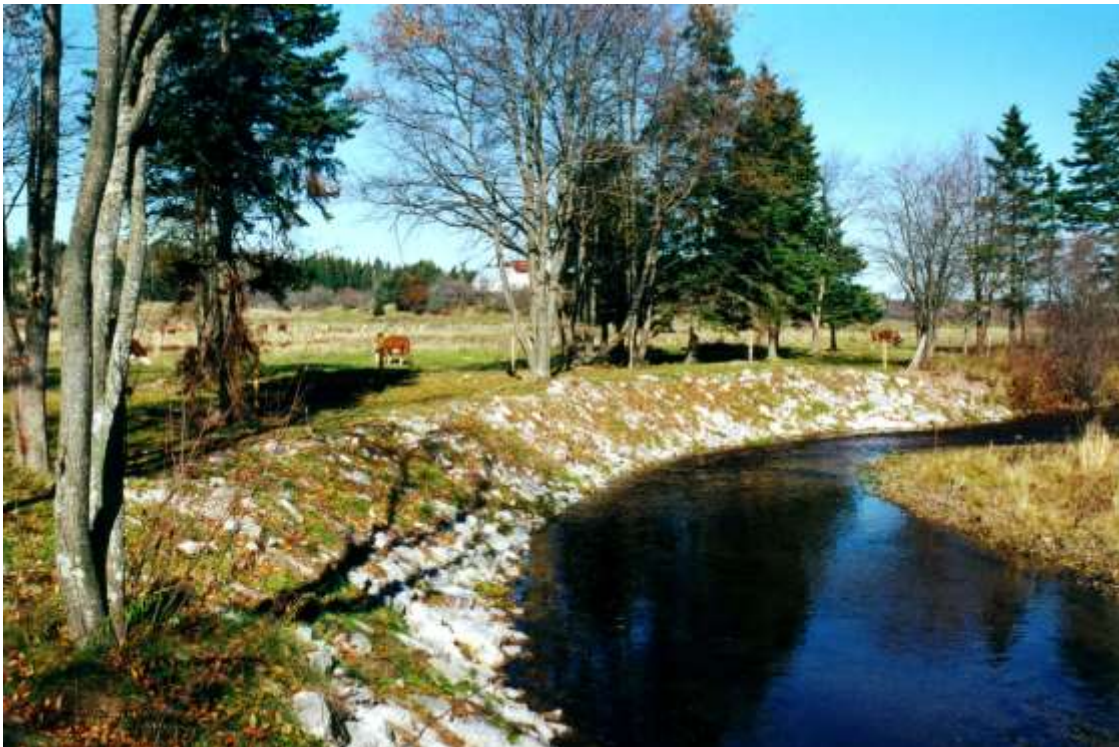
35. Anderson Farm Site (45.82723, -65.44761)

Some of the banks on Smith's Creek needed fast action due to excessive erosion. Planting trees and fencing cattle out would not have helped these actively eroding sites. More direct actions such as installing riprap and back-sloping were necessary to stabilize the banks. Riprap is the armoring of a bank with blasted rock. The stream banks are back-sloped and blasted rock is placed with an excavator to create protection for the bank against water and ice. Riprap was installed at eight locations on Smith's Creek, protecting a total of 782 metres of streambank from further erosion, including at the Anderson Farm in 2000.

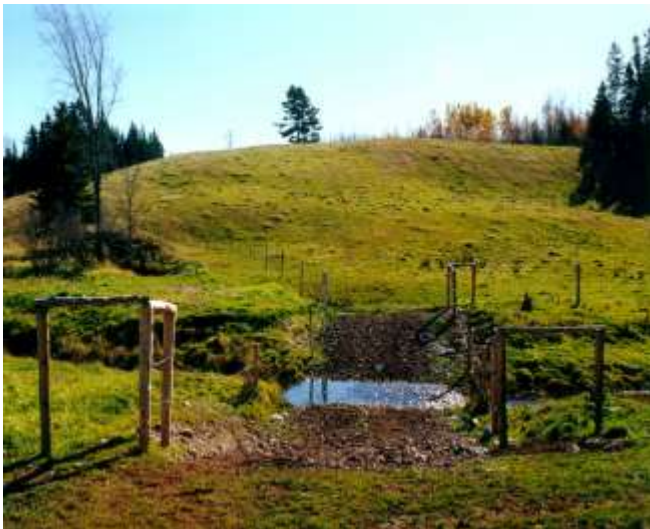
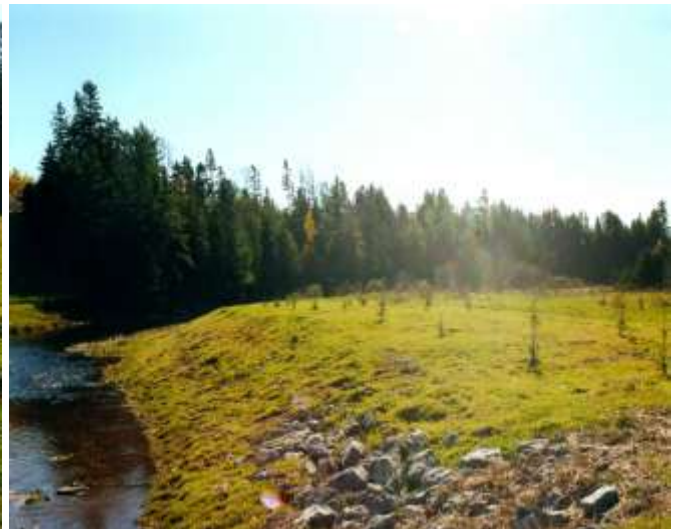
36. Kuin Farm Site (45.84021, -65.42678)

Beginning in 2000, Kuin Farms was restored through tree planting and back-sloping. First, fencing was installed to protect the riparian zone from the impacts of livestock. The streambank was then back-sloped and a rock toe was placed at the bottom of the slope for added protection. Finally, the streambank was seeded to accelerate re-growth and trees were planted to offer future protection with their root systems. Re-establishing riparian vegetation helps to provide shade to the stream and to filter out sediments and excess nutrients.

A total of 5,500 seedlings and 450 large stock trees were planted, thanks to generous donations from J.D. Irving, Limited, Woodlands Division and the Department of Natural Resources and Energy. Approximately 63 metres of streambank was stabilized on the Kuin Farm.

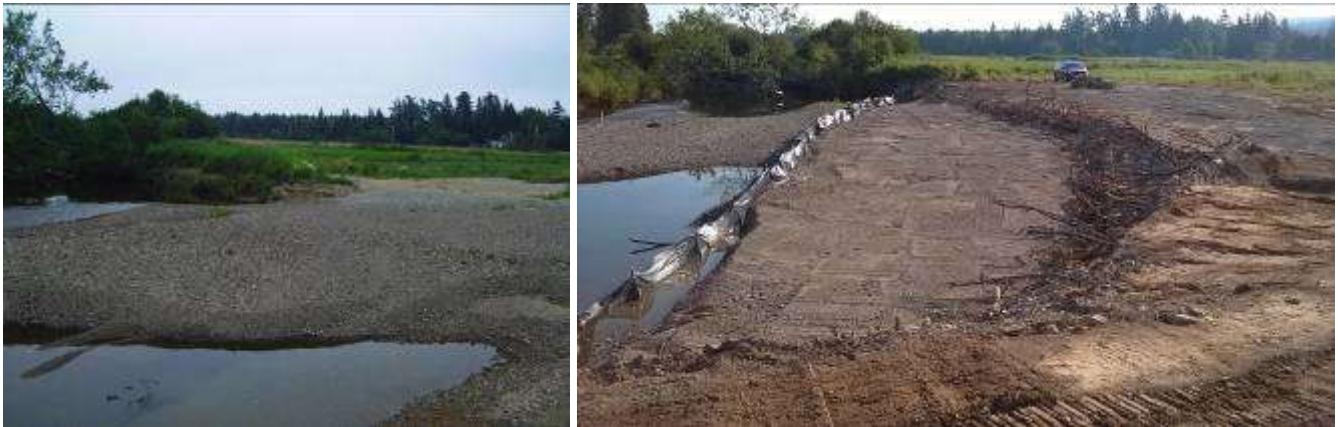
Partnering with Mr. David Hayes, the KWRC re-assessed and created a restoration plan for this section of the Millstream River. The trees for the tree revetments came from non-merchantable stock being harvested by the Town of Sussex off O'Connell Hill. The goal of our restoration efforts was to encourage the formation of a more stable streambank while continuing to maintain the river's connection to the floodplain. This will reduce gravel depositing on the farm field while also minimizing the impact from sediments and nutrients flowing into the river from the crop fields.

This site resulted from a flood event beginning to form a flood channel and deposition area in the field. We re-shaped and stabilized the bank using tree revetments.

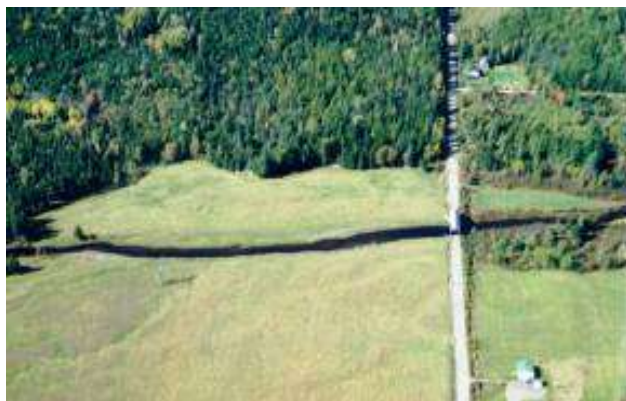
Before restoration.

Restoring the health of the river on this property involved several methods. The KWRC stabilized a fording site, creating a safe area for livestock and machinery to cross without negatively impacting the river, and six rock sills were placed in various locations throughout the stream. Staff also installed a two-strand, solar-powered, electric fence to restrict cattle access to the ford; this fence is removed each winter and re-installed in the spring to prevent damage from winter conditions. There have been more than 3200 trees planted at this site, including willow, pine, and spruce; staff members return each year to spot-plant as necessary. Finally, staff installed eight bird boxes, two duck boxes, and one bee box on the property to enhance habitat for wildlife.

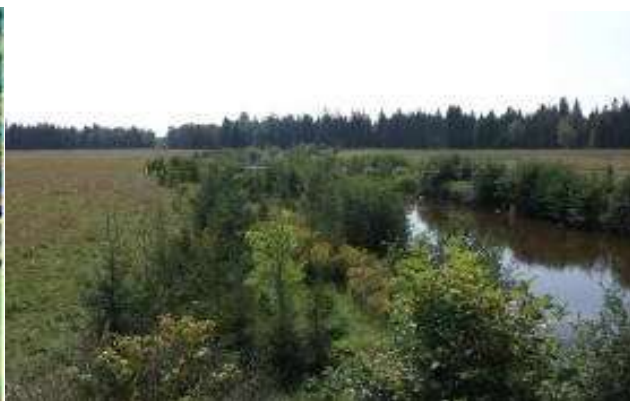
After bank stabilization and tree planting.

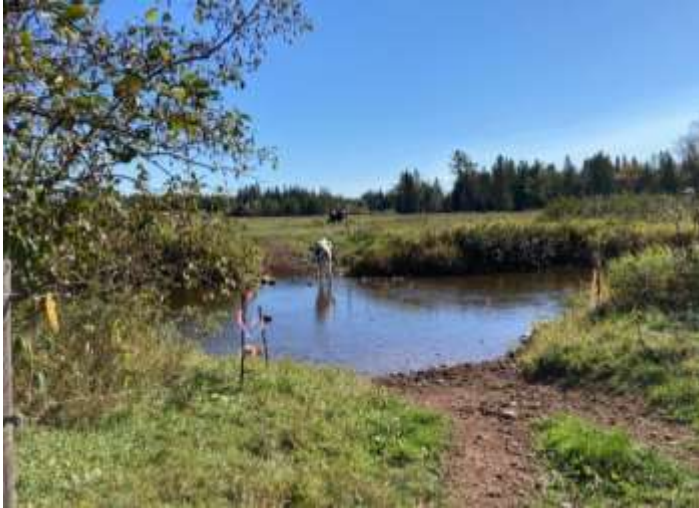
Recent Site Photos:**A cow crossing the ford in the fall of 2020.**

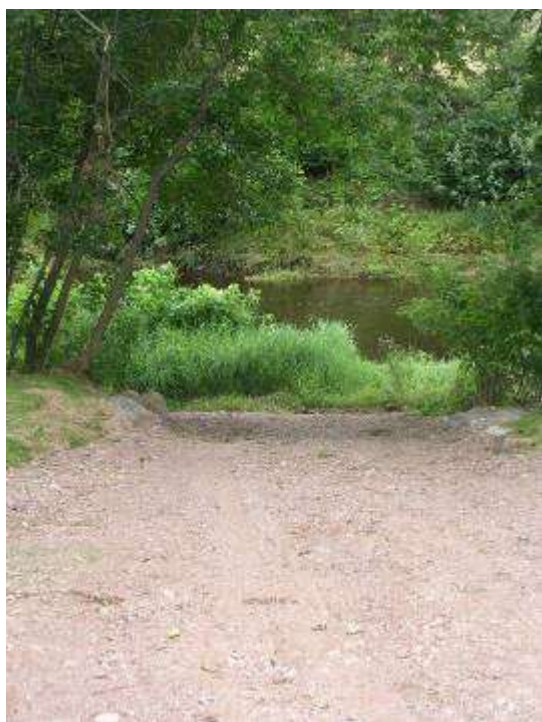
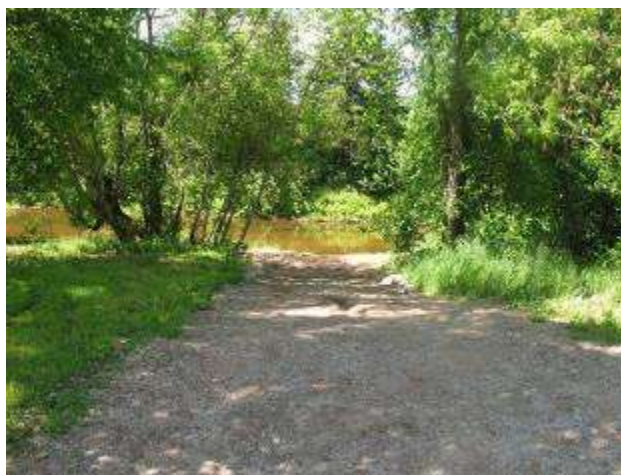
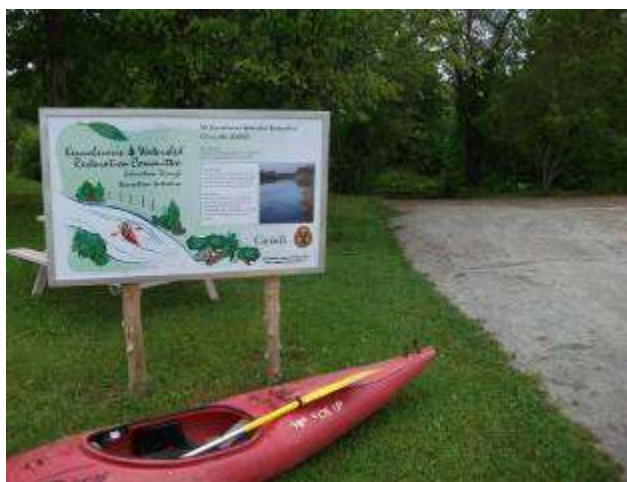
39. Apohaqui/Lower Millstream Recreation Council Boat Launch Enhancement Project (45.70306, -65.59923)

A long-established boat launch at Jones Memorial Park at the mouth of the Millstream River was becoming degraded and vehicles were eroding the streambank and park grounds when launching small boats. To improve these conditions, the KWRC, in partnership with the Apohaqui/Lower Millstream Recreation Council Inc., enhanced the access road and the launch site by decreasing the slope of the access road and using large boulders. These efforts will help to prevent future erosion while maintaining the natural look and feel of the site.

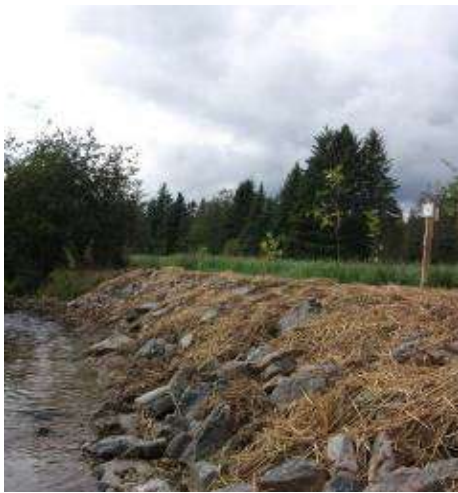
One of the improved banks.

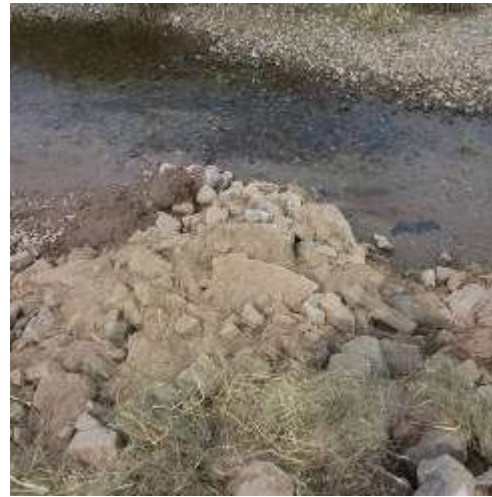
An installed rock groyne.

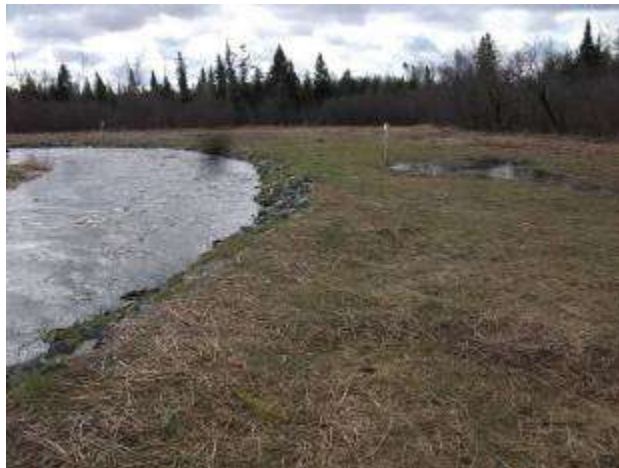
Lower bank under high water conditions.

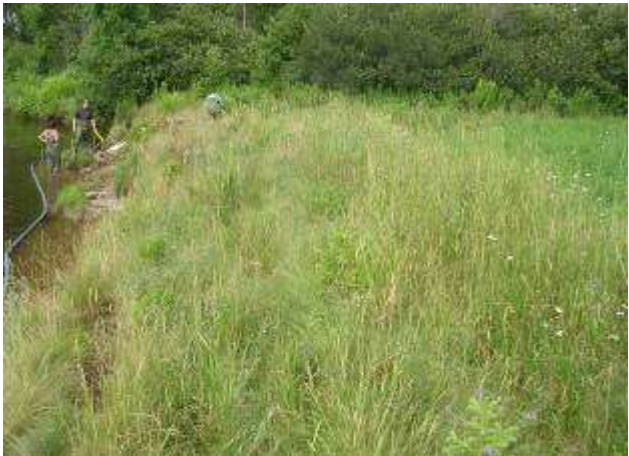
Before

This site is situated along the main stem of the Millstream River. Completed in 2012, the project allowed us to build-upon work completed upstream around 1999-2002. The landowner, Don Folkins, approached us through the Kings County Agri-Conservation Club to restore a severely eroding bank.

The KWRC used fascine bundles to stabilize the eroding stream bank and improve the health of the riparian zone. Volunteers helped to complete the first 50 metres of bank stabilization work as part of our “2012 Water and Willows” event.

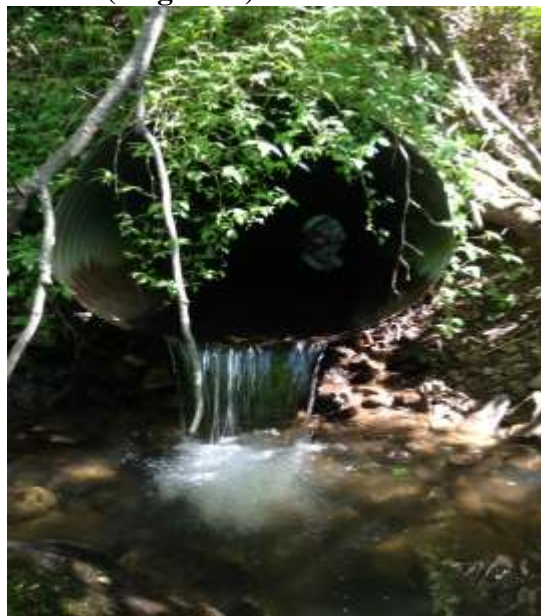
Before (Aug 2017)

On August 10th, 2017, a rock weir was installed on this brook, but due to the low flow and the fact that the majority of the water was flowing underneath the culvert, rather than through it, KWRC staff were not successful in decreasing the perch to <10 centimetres. Staff were able to decrease the perch to 24 centimetres and did not want to disturb the pool habitat or cause additional stress to the fish species using it by attempting to raise it any further. The KWRC intends to re-visit this site during higher flow and assess whether further work can be done to increase fish passage or if this site is a better candidate for a culvert replacement. Fish passage may now occur beneath the culvert but that is difficult to determine.

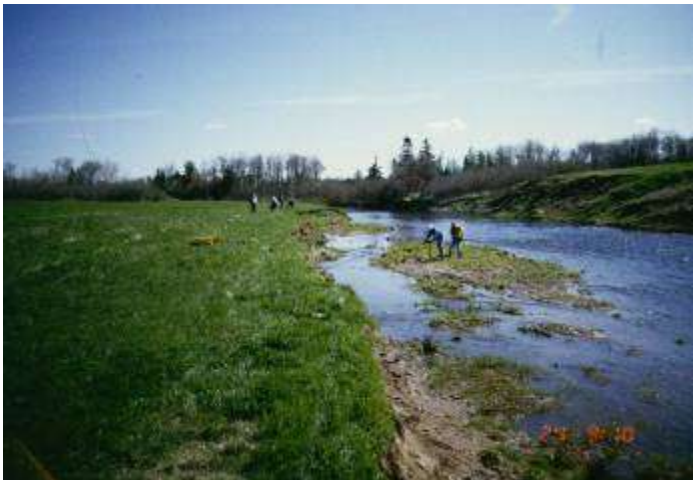
This site is one of our more mature willow planting sites and we now harvest stock from this site to propagate willow for other restoration efforts. At the site, the KWRC had installed rock sills and planted the riparian zone both above and below the bridge on Highway 10. The restoration efforts here have stabilized the streambanks and will help to improve water quality, reduce stream temperatures, and reduce excess nutrients entering the waterway. The landowners have provided a larger setback than required by New Brunswick's Clean Water Act.

The Berwick Corner site circa 1999.

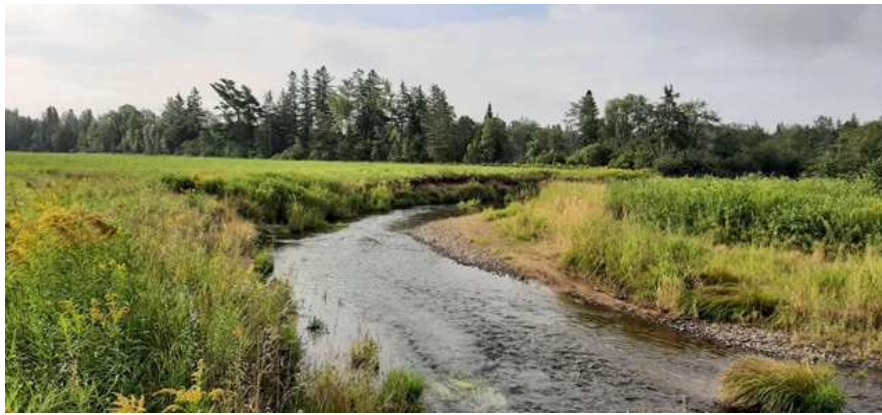
This site is located along an old agricultural field that has become eroded along an oxbow turn on Millstream River. In 2021, the team stabilized 135m of the bank using a hybrid bioengineering approach that includes a rock-toe, brush layer, back sloping, and geo-roll installation. Through bioengineering, the KWRC team staked 1600 willow along the toe of the restored bank. To stabilize this bank, we required a large riparian setback. The landowners allowed us to implement a 15m buffer where the team planted 649 trees along 255m.

BEFORE

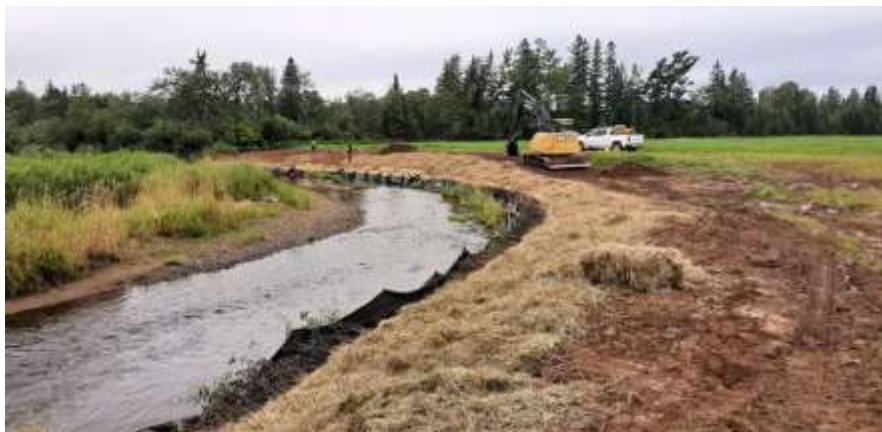
AFTER

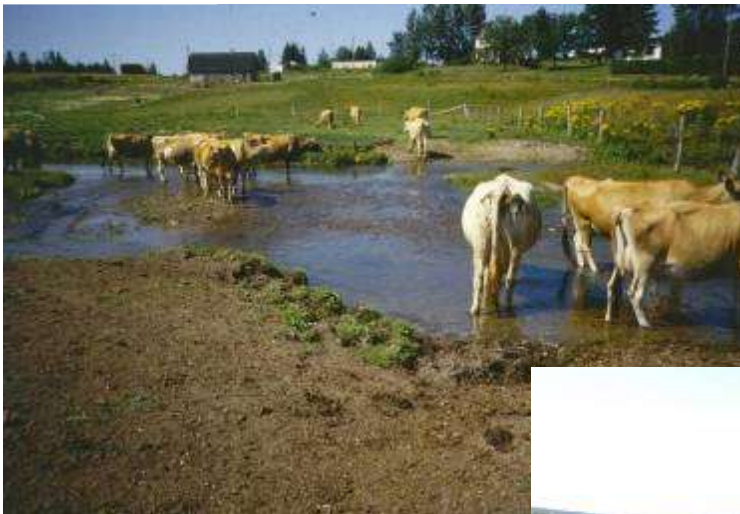
This site is one of our oldest restoration projects and was originally completed in 1996. As a cold-water stream, McLeod Brook is an important component of the overall health of the Upper Kennebecasis sub-watershed. To restore the stream health and riparian zone at the site the KWRC installed more than 30 digger logs, created fording sites, erected livestock fencing, and planted trees. The pictures below indicate the site has become a large success. The digger logs have stabilized the stream and created deep pools for salmonid refuge. The livestock fencing has helped to protect the trees that were planted, giving them a chance to grow and re-establish the previously degraded riparian ecosystem.

Site in 1996.

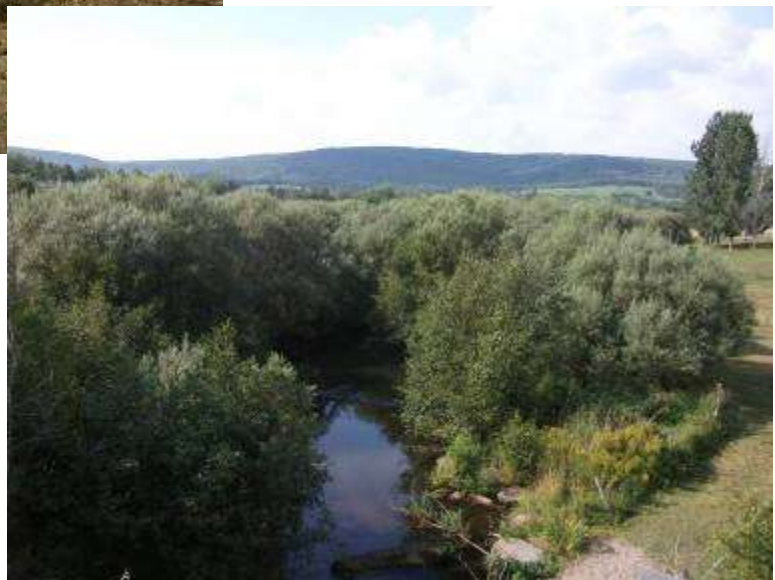
Site in 2010.

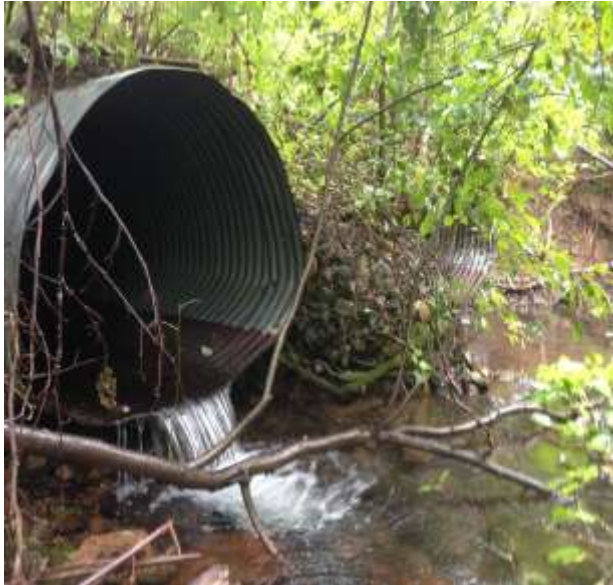
This rock weir was installed as part of our *Fish Passage Barrier Removal Project* in 2016 and is located on McLeod Brook, a cold-water tributary to the Upper Kennebecasis River. Before installation, the culvert had a perch of 22 centimetres which was restricting fish passage. After the rock weir was installed the perch was less than 8 centimetres, successfully improving fish passage. Thanks to this project, an additional 1.5 kilometres of viable habitat is now accessible to fish species.

Before

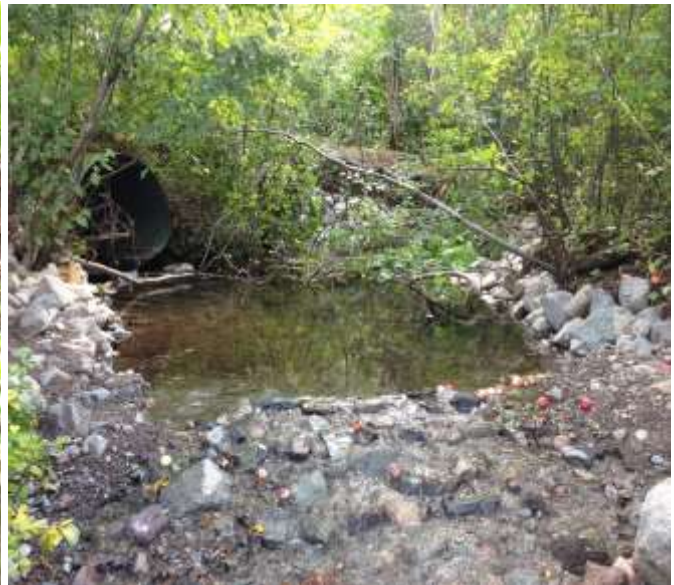
After

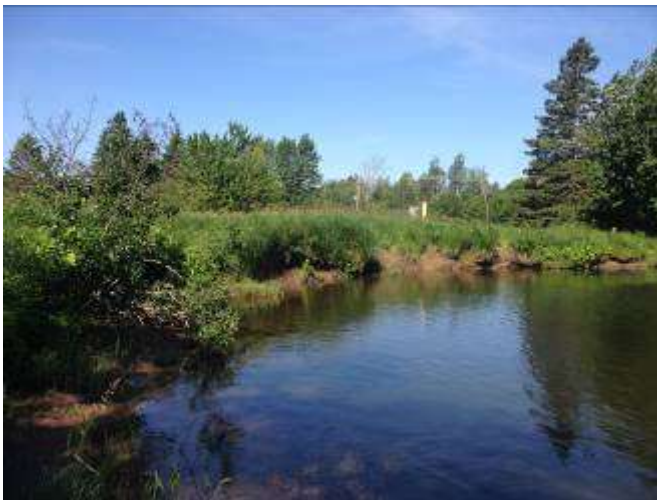
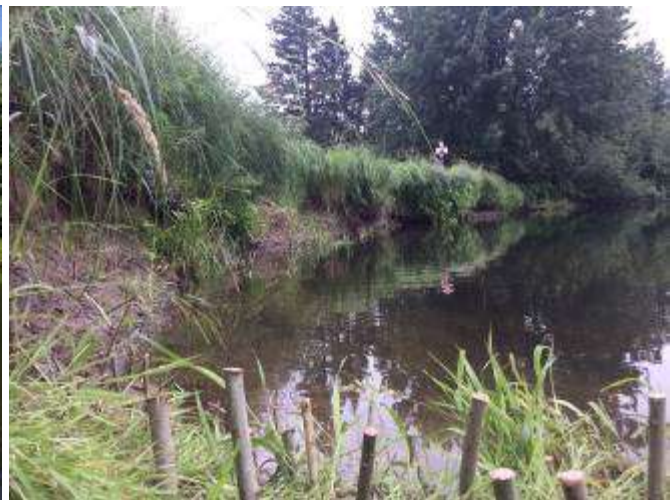
As part of our *Upper Kennebecasis Triage Project* in 2017, this site was identified using aerial imagery as a degraded riparian zone. After site identification, our field crew performed a thorough assessment to determine which restoration efforts would benefit the site. The landowner, Kingsco Transport Ltd., was approached and approved the restoration efforts we had outlined for this location. The streambank was severely eroded and composed of fine sediments. The KWRC decided the site would benefit greatly from improved vegetative cover. A total of 1142 willow (450 willow seedlings, 692 willow stakes) were planted along the toe of this site. A 5 metre setback was also established along the 50-metre-long bank. Within the newly established riparian setback, we planted 28 potted stock trees (26 balsam fir and 2 Eastern hemlock). We also installed a duck box on the property to enhance wildlife habitat.

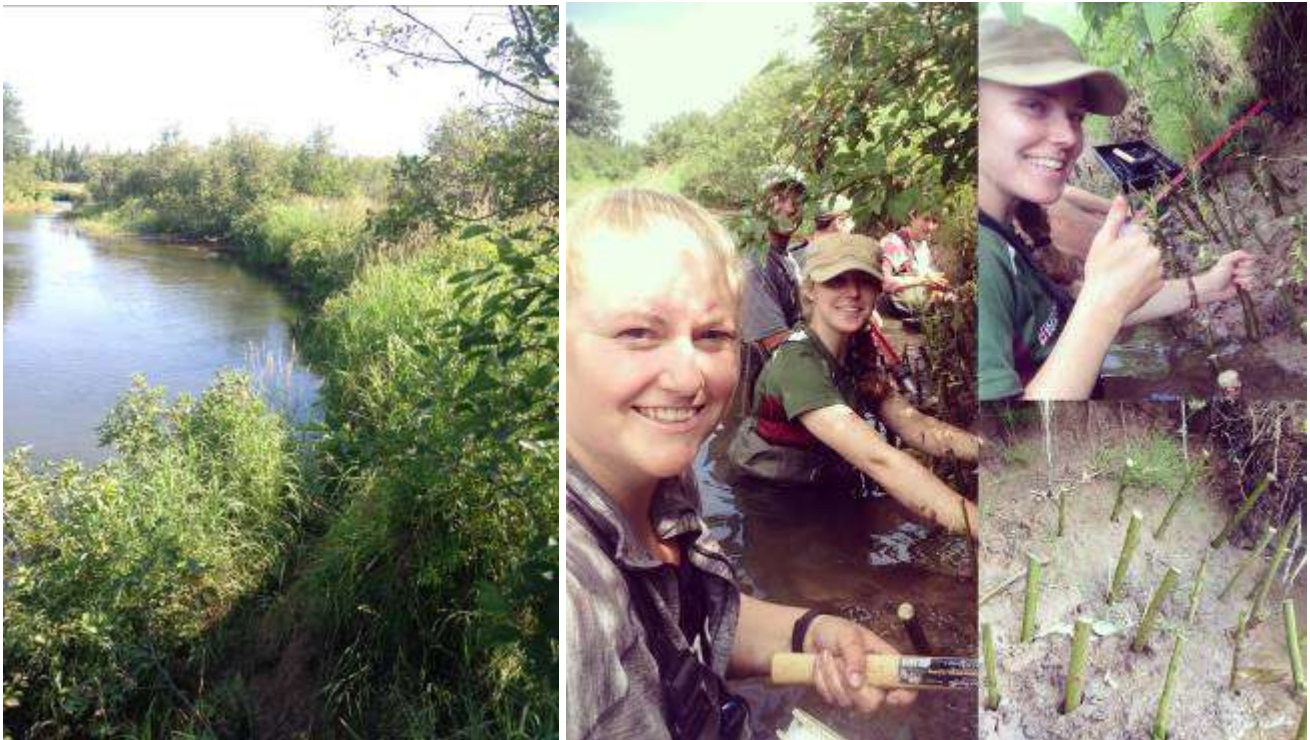
This site was identified for our *Upper Kennebecasis Triage Project* in 2017. After completing a site assessment, the KWRC approached the Sussex Fish and Game Association and they approved our restoration plan. The bank in this location was severely eroded, so we decided the site would benefit from improved vegetative cover. A total of 1044 willow (660 willow seedlings, 384 willow stakes) were planted along the toe of the streambank. A 5 metre setback was established along the 108-metre-long bank we stabilized. Within that newly established setback, we planted 28 potted stock trees (9 balsam fir, 3 Eastern hemlock, 8 black spruce, and 8 white spruce). We also installed a duck box on the property.

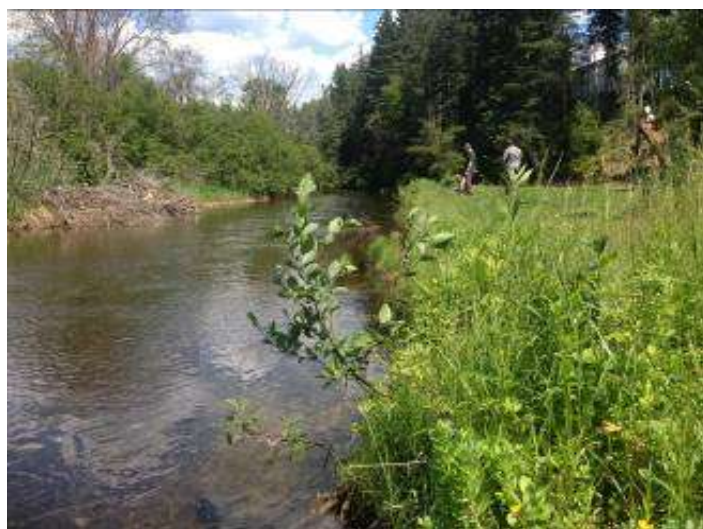
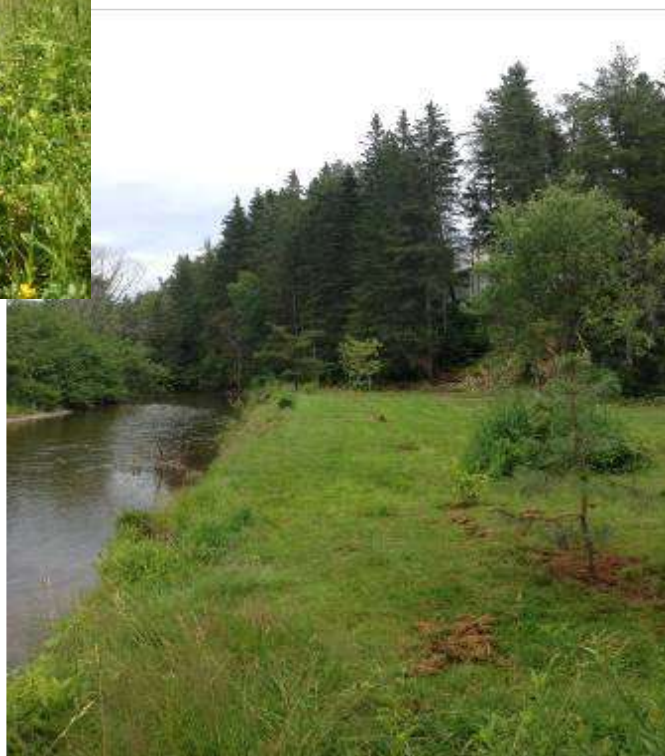
This site was first identified in 2016 during our Upper Kennebecasis Habitat Assessments. The KWRC restored this site in 2017, as part of our *Upper Kennebecasis Triage Project*. This site was lacking vegetation and experiencing severe erosion. The streambank is 81 metres long and the landowner agreed with our restoration plan. The KWRC planted 1556 willow stakes along the toe of the streambank. As the willow mature, we hope they will stabilize the bank and prevent future erosion. We also planted 12 shrubs, 5 red osier dogwood and 7 service berry, as well as 6 large caliper stock trees, including 2 red oak, 2 serviceberry and 2 red pine. If the planting doesn't help we may re-assess this site for more substantial stabilization techniques as there is room for back-sloping at this location.

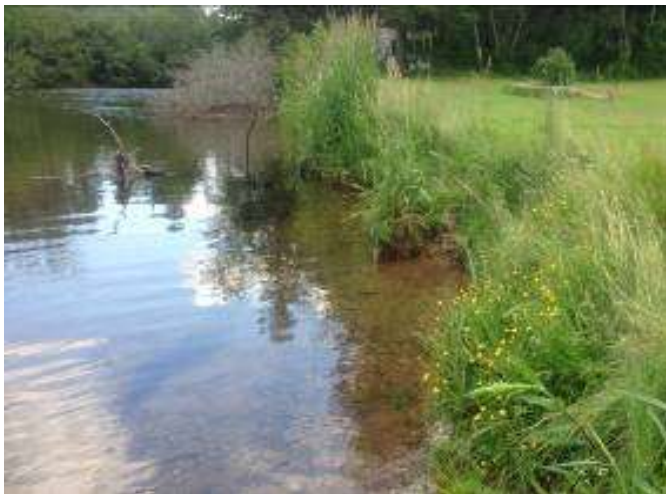
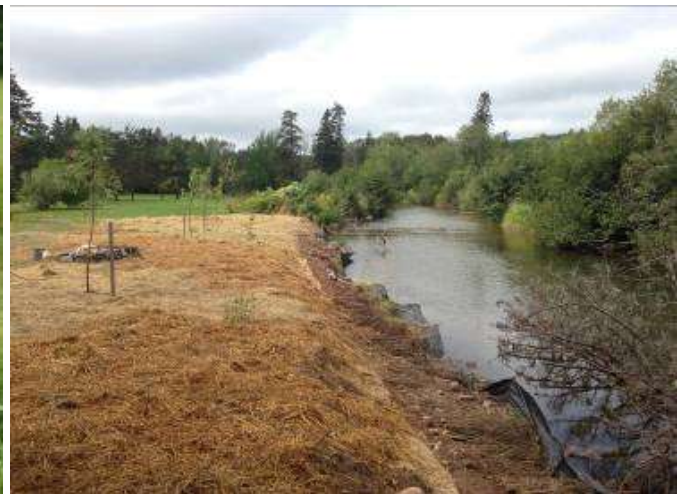
This site was first identified in 2016 during our Upper Kennebecasis Habitat Assessments, then was restored during our *Upper Kennebecasis Triage Project* in 2017. This site is 48 metres in length and suffers from heavy erosion and lack of vegetative cover. We installed a rock toe along the streambank, two geo-roll steps, and a brush layer of 300 willow whips. Tree stock was also planted throughout the newly established riparian area. As the landowner wanted to maintain access to the river, staff planted willow stakes on the geo-roll steps but left 20 metres open. This approach was used when planting trees and shrubs as well. The KWRC planted 6 red osier dogwood shrubs and 4 silver maple and 2 serviceberry caliper stock trees. The area was re-seeded and watered weekly to remediate the site back to its prior visual appeal. As the vegetation matures it will protect the bank from erosion, create shade cover, and mitigate impacts from high water events.

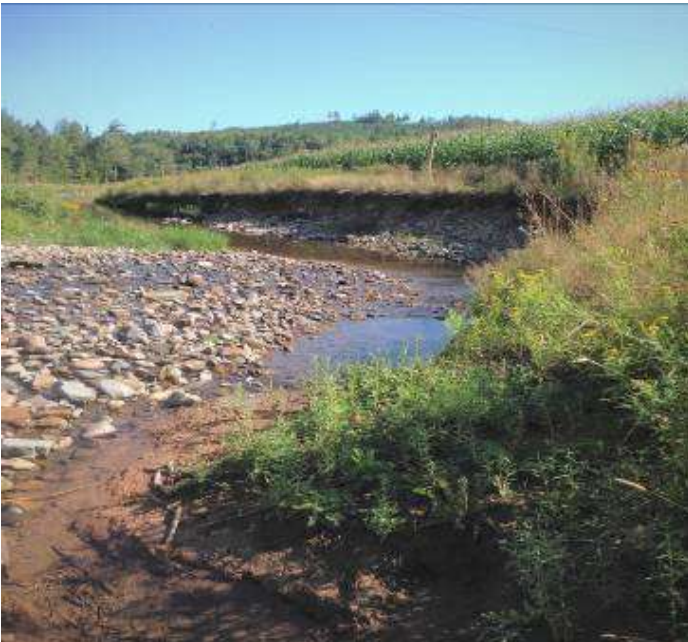
This site was identified and restored as part of our *Upper Kennebecasis Triage Project* in 2017. On the property, there was a 90-metre-long portion of streambank that was severely eroded. The stream channel had split and washed away a large portion of the landowner's farm field. The KWRC suggested heavily staking the newly formed streambank with willow and planting vegetation within a 5 metre riparian setback above the bank. We planted a total of 2039 willow stakes along the 90 metre bank as well as 26 potted stock softwoods in the riparian zone (24 balsam fir & 2 white spruce). The roots of this newly established vegetation will help stabilize the bank and provide shade to the stream as it matures. Two bird boxes were also installed at this location as well.

Before

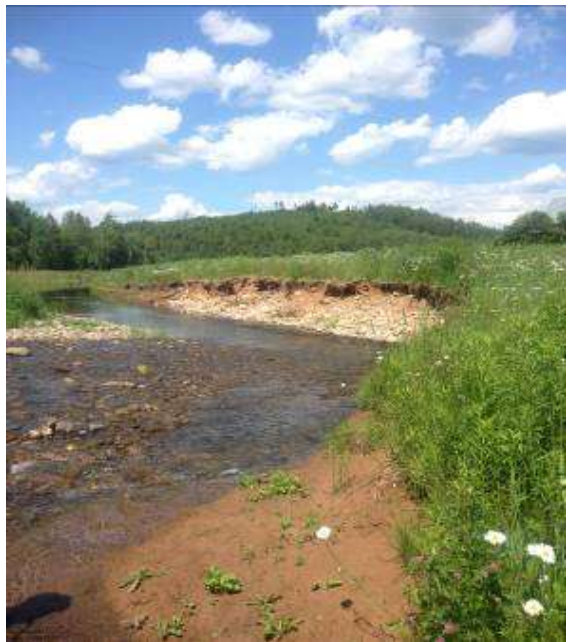
After

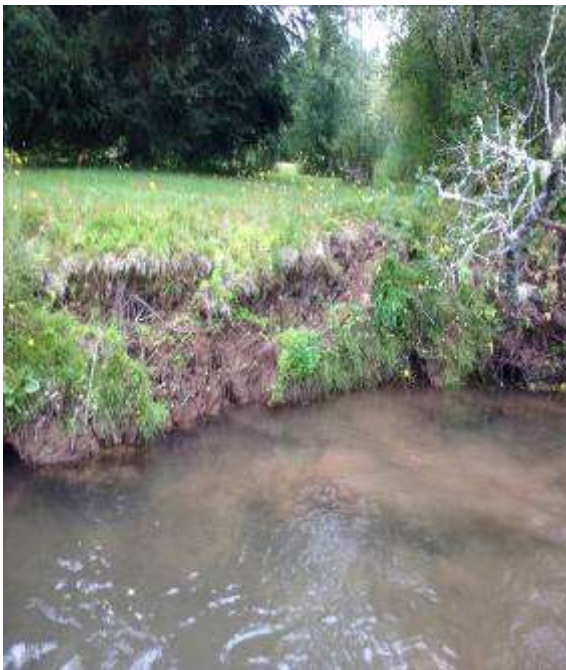
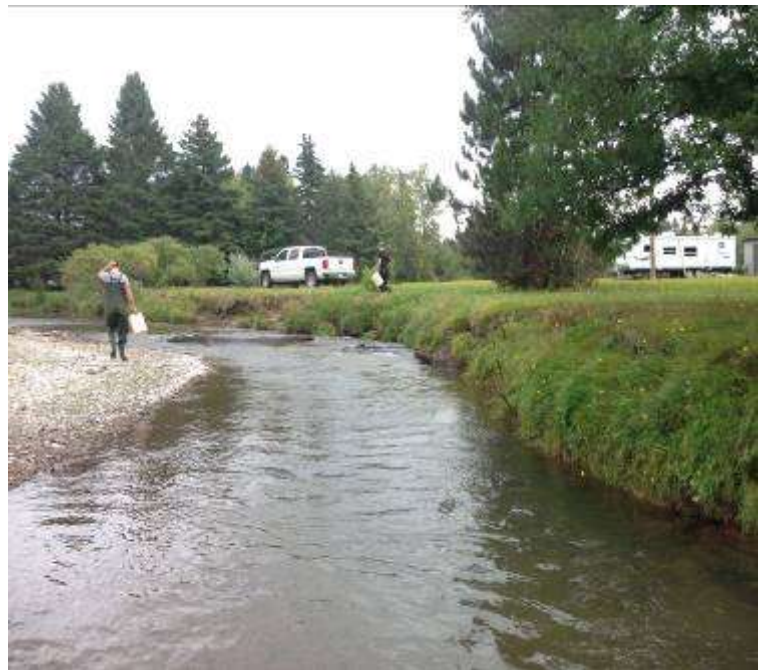
This location was established during our *Upper Kennebecasis Triage Project* in 2017. Bob Missen was a new landowner on the Upper Kennebecasis and in the years since acquiring his property, he found that he had lost a significant portion of his land due to erosion. The area of concern is 63 metres in length and it lacks significant vegetation as it was being mowed to the top of the bank. Although it was late in the field season when this property was brought to our attention, we decided to plant the streambank and hope that enough vegetation was established to withstand the spring freshet in the following year. We staked 1084 willows along this streambank in late 2017. We intend to monitor this site in 2018 and depending on how it holds up this coming spring we plan to consider it for more substantial restoration work.

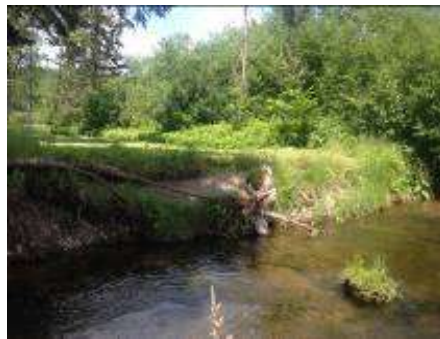
As part of our *Upper Kennebecasis Triage Project* in 2017, we established three planting sites on Stephen Moffett's properties. The first site on the Upper Kennebecasis spanned 20 metres and suffered from severe erosion. We planted 99 willow seedlings here and placed hay to mitigate erosion and establish a 5 metre setback.

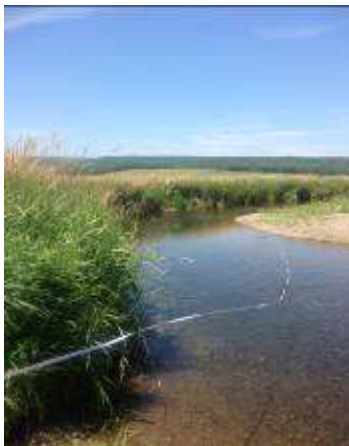
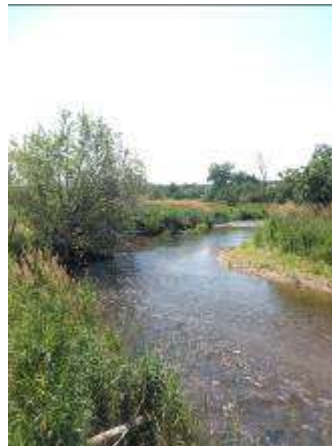
The second and third sites are located on the Upper Kennebecasis downstream from the first site. The site on the right bank is 75 metres in length and is next to a hayfield. Downstream, on the left bank, is an additional 87 metres of eroding streambank next to a cattle-grazing field. Fencing is in place and a 5 metre setback has been established. Between these two sites, 773 willow seedlings were planted, 139 willow stakes, and 20 trees (16 balsam fir & 4 white spruce).

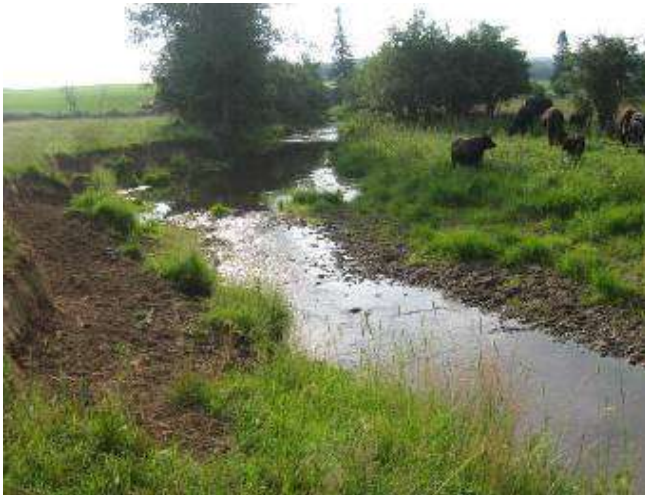
In 2008, this project stabilized an eroding streambank while also improving riparian zone health on Musquash Brook. Just over 45 metres of eroding stream bank was stabilized using rock armouring and rock kickers to slow water flow. Livestock fencing was erected to protect the riparian zone while still providing a restricted area for watering. The farmer also agreed to alter his practice of grazing both sides of the stream and changed one pasture into a crop field. The following year two other eroding banks were stabilized and the riparian zones were enhanced through tree planting further down the stream.

The site in fall 2007.

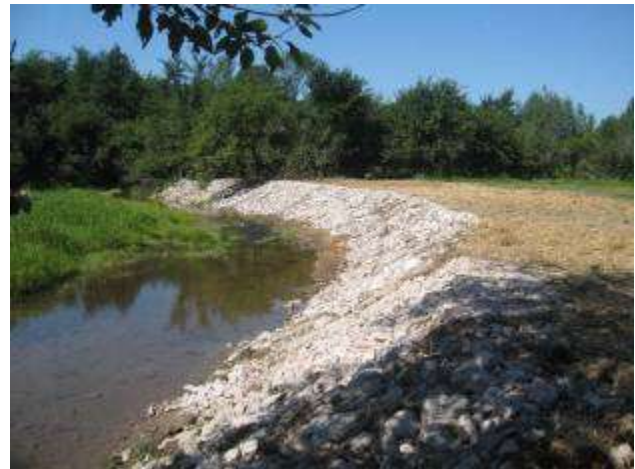
The site during work in 2008.

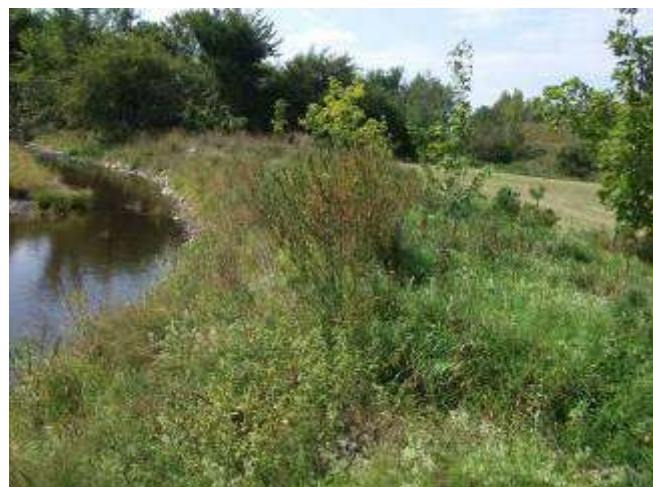
The site in 2010.

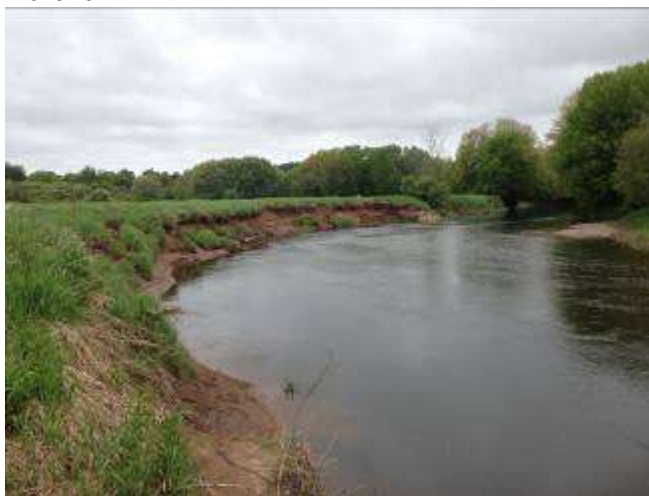
The KWRC approached Derm and Mary-Claire Murphy in June of 2017 after identifying their property online. It appeared online that the property lacked vegetation along its riparian area. Our restoration team assessed the site and decided to heavily plant the streambank with willow stakes and seedlings. A total of 900 willow seedlings and 2328 willow stakes were planted along the 90-metre-long bank. The roots of the willow will stabilize the bank as they grow. Above the bank, the KWRC established a 5-metre setback by planting 3 red osier dogwood, 16 balsam fir, and 3 red oak. These species will also help stabilize the bank, and provide shade cover to the river as they mature. This effort will help in decreasing future stream temperatures, improving aquatic habitat.

Before

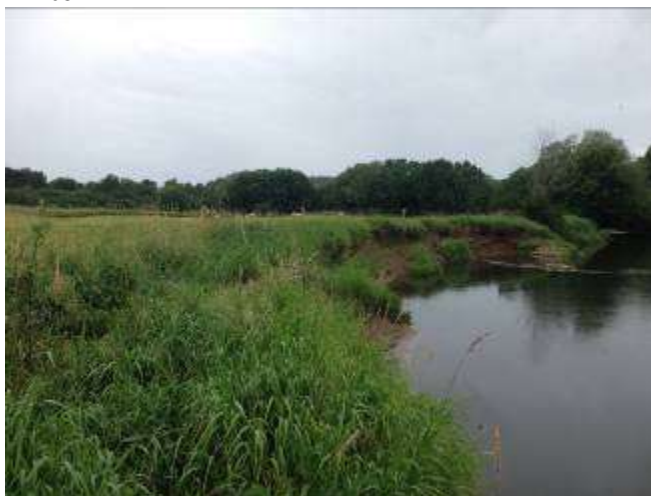
After

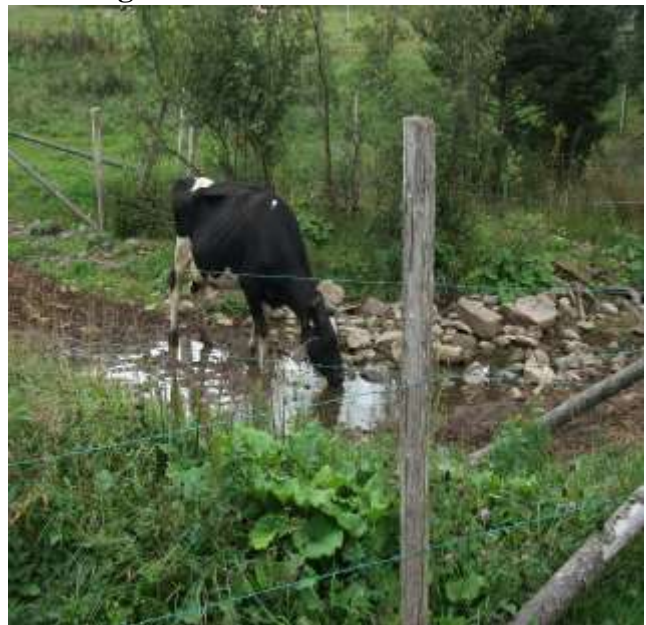
Fording Site Installed

To further improve site conditions, the KWRC worked with the landowner to provide a stable agriculture ford. Prior to this project, the farmer was utilizing an equipment crossing area that impacted over 30 metres of stream length. The KWRC was able to improve the approach and crossing of the ford so that now only 5 metres of stream length is impacted. This crossing provides water access for cattle and allows the farmer to safely cross with machinery.

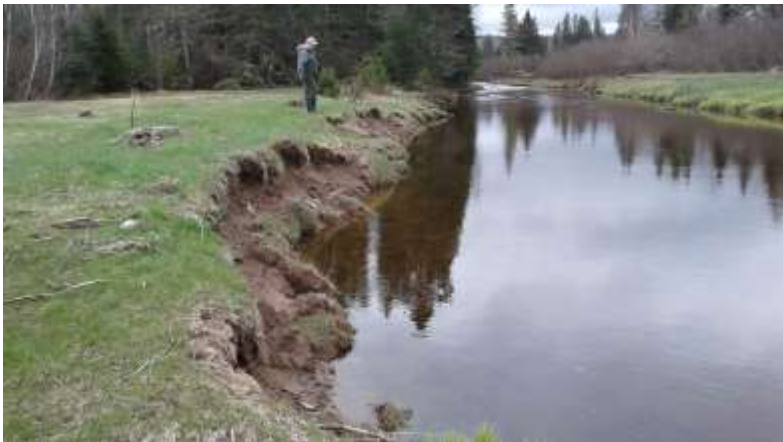
The *Moosehorn Creek Enhancement Project* included installing approximately 1650 metres of electric fencing, planting 295 trees and 1775 willow, stabilizing over 90 metres of eroding stream bank, installing four bird boxes and two duck boxes, and improving a fording site so that the entire site could be safely accessed. This work will help to decrease stream temperatures, enhance habitat for wildlife, and prevent future erosion and sediment loading.

A section of the streambank before restoration efforts.

The same section of streambank after restoration efforts.

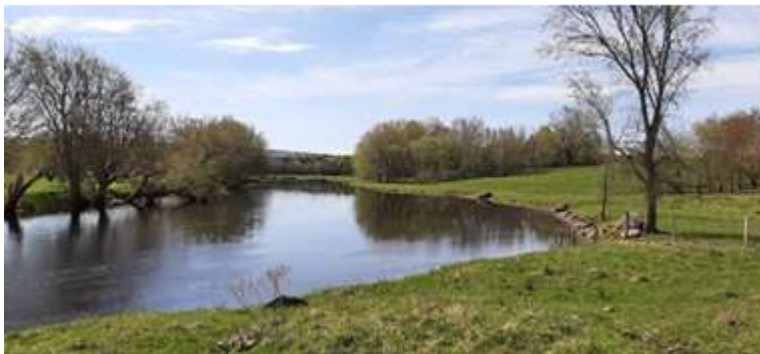
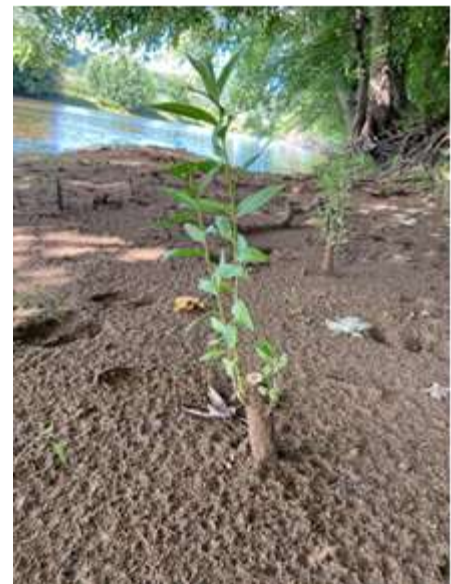
61. Cattle Fencing and Bank Restoration - Don Bettle's (45.573852, -65.776966)

Don Bettle reached out to the KWRC in early 2022 for riparian enhancement along his agricultural fields. Through ASCF, ETF, WWF, WTF, and EcoAction we were able to add long-term bank stabilization, create a large riparian setback, and install riparian cattle fences. In total 1.31 kms of stream bank was willow staked, planted, and fenced. The KWRC staked 3741 willows, planted 814 trees, and installed 8 bird boxes and 4 duck boxes. This site is also home to our new carbon monitoring and pollinator monitoring sites.
