KENNEBECASIS WATERSHED RESTORATION COMMITTEE

Restoration Site Portfolio

1995-2022

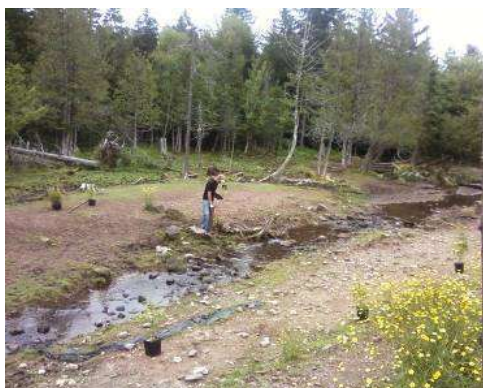
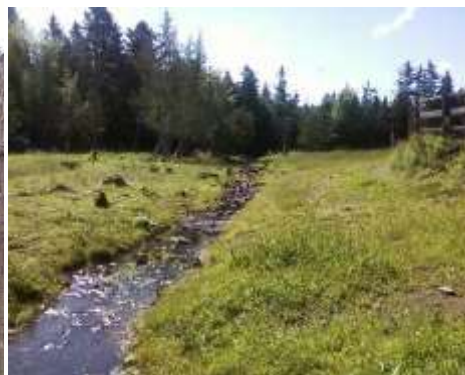
62. Hampton Bible Camp Riparian Restoration Project (45.49735, -65.8318)

Crews planted seedlings and spread triple mix grass seed to enhance the site.

Through one season, the difference in site aesthetics and ecological integrity is astounding.

The board of the Hampton Bible Camp approached the KWRC to request we work with them to improve the conditions of the stream running through their property and pond. The pond is used for swimming and boating by campers and the stream is a trout-bearing tributary to Grooms Brook. Before restoration took place the stream was over-widened and horses from the camp's stables had free access to the stream. The riparian zone was degraded and nutrients and bacteria issues were arising in the pond. The KWRC installed fencing to restrict livestock access and planted the riparian zone with cedar, willow, spruce, and maple.

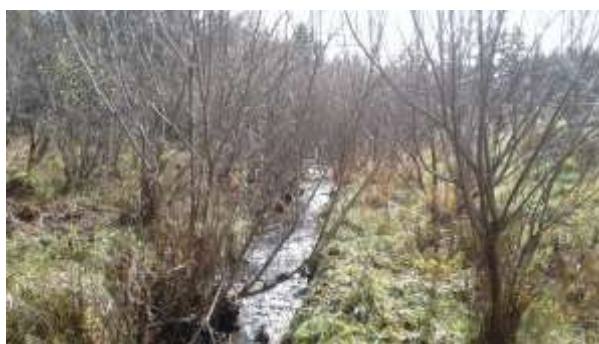
After years the site has established lots of growth

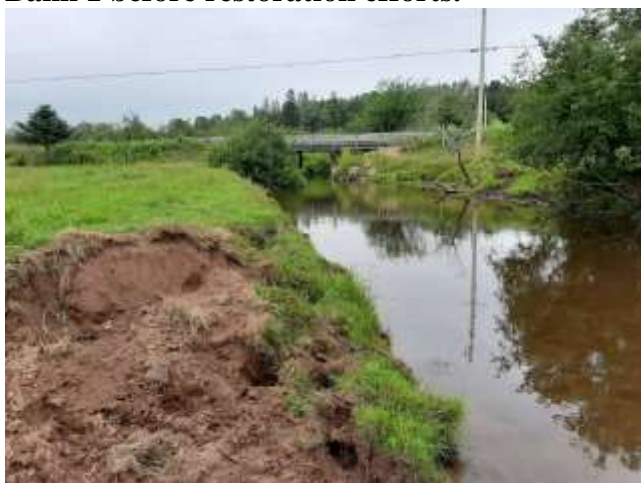
Bank 1 before restoration efforts.

We focused on stabilizing three sections of the stream bank; the work at each section included back-sloping the bank, then installing a rock-toe, willow brush layer, and three geo-rolls. To enhance the riparian zone, our staff planted approximately 1200 willow stakes and whips, and 200 trees; this planting occurred within the agreed-upon 5-metre riparian setback. As this site is located on agricultural land, we used a solar-powered electric fence to protect the banks and vegetation. In total, 106.5 meters of stream bank was stabilized and 5600 square meters of riparian zone was enhanced on this property.

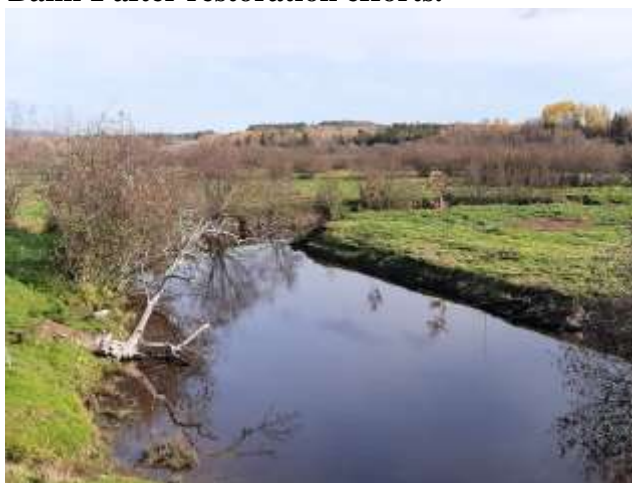
Bank 1 after restoration efforts.
